BASELINE DOCUMENTATION REPORT

**FOR
LAKE FOREST ESTATES
MACEDONIA, OHIO**

SUMMIT COUNTY, OHIO

**September 15, 2006
January 5, 2007**

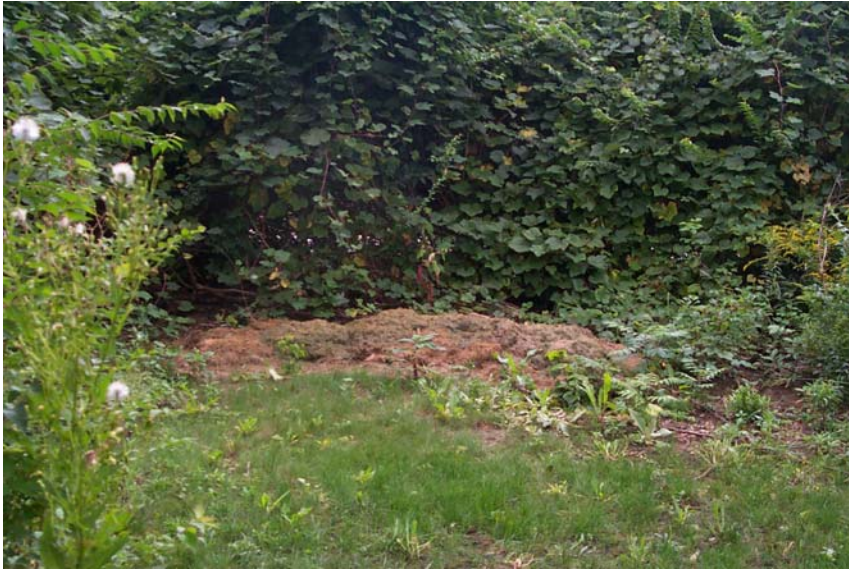
Portions of the CE between Valley View Road and the homes on Pond Brook Lane have been encroached upon. Behind S/L 116 are mounds of grass clippings and a mowed

area within the CE (see photo 1). CE at the back edge of S/L 118 has woody debris (see photo 3). Cut vegetation was observed behind the model home on S/L 114 (see photo 5). The natural area of the CE on the back edge of S/L 1 is gone and has been replaced with an entrance garden area leading into the development (see photo 6).

Photo 1: View SW from SL 116 into CE.

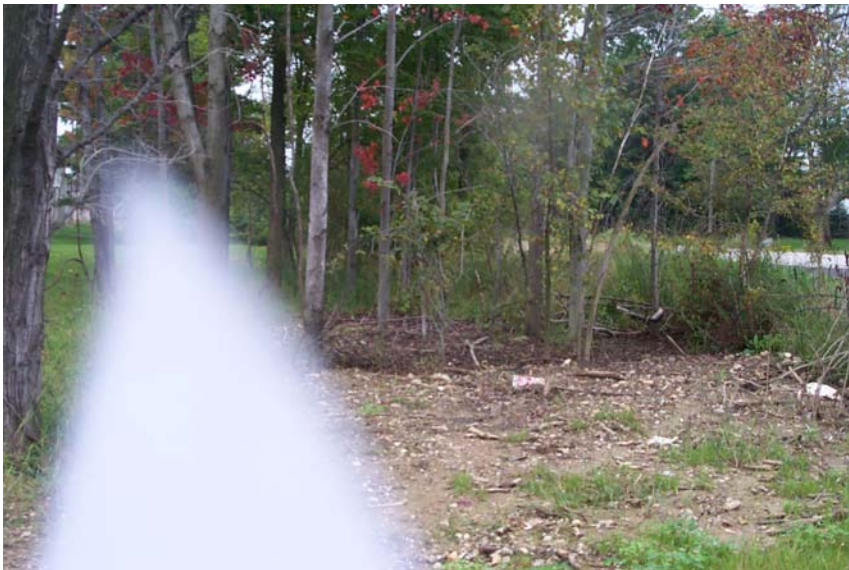
Photo 3: View S into CE at corner of whispering Woods Drive and Valley View.

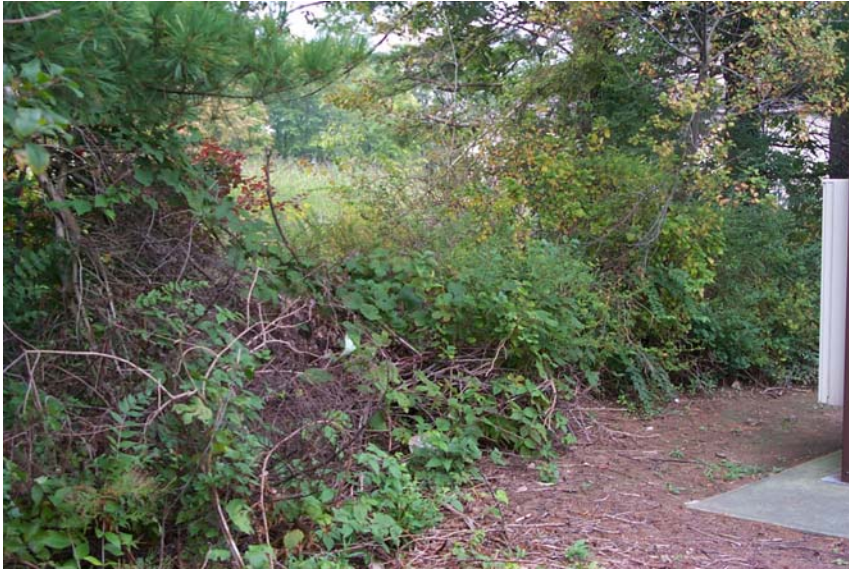
Photo 5: View NE into CE, to model home on SL 114 from Valley View.

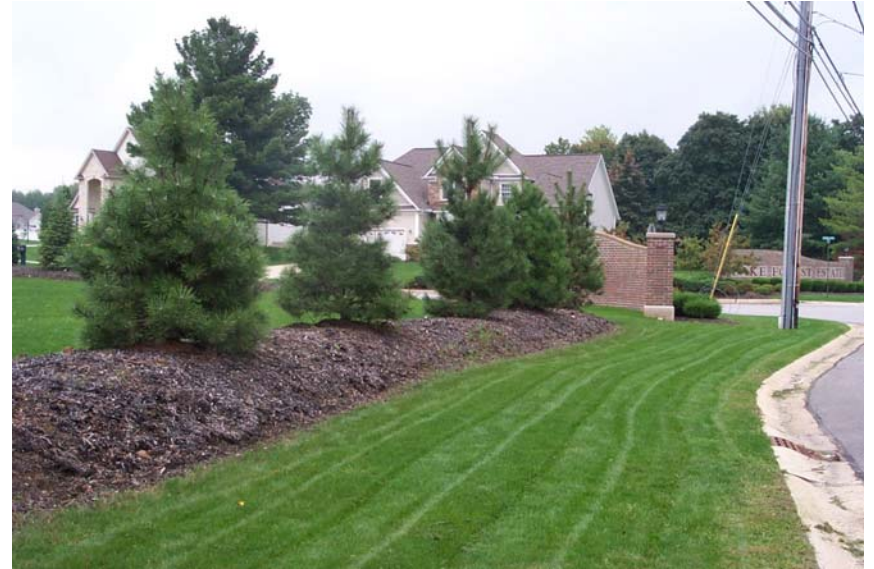
Photo 6: View SE, CE to left, Valley View to right to River Run.

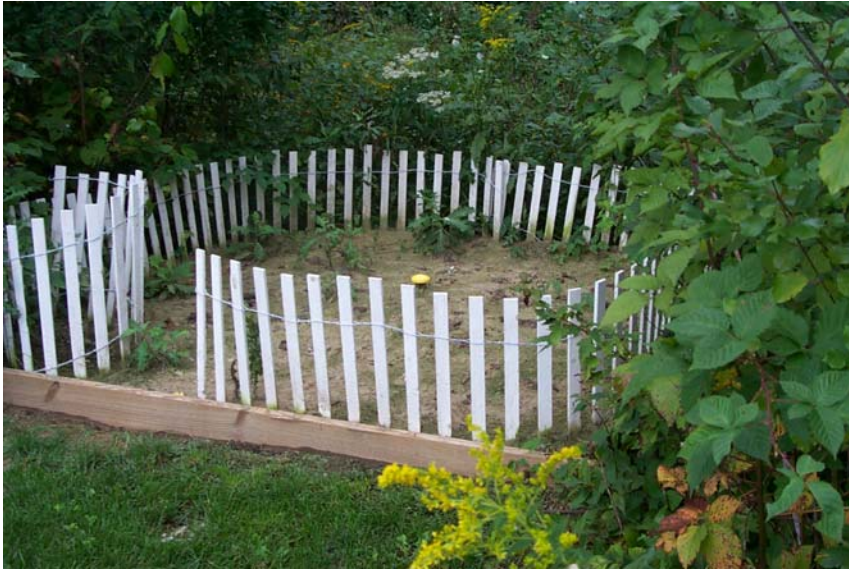
There are several properties encroaching the CE located off the southeast corner of River Run Drive. S/L 21 off Dresser Lane has a small garden that appears to encroach the CE (see photo 9). A small pond in what is understood to be CE on S/L 22 (no OSP signs or stakes were observed) has been dug and actively holds water (see photo 14). A drainage pipe from S/L 22 empties into another depression, which is separated from the pond by a small berm (see photos 15-17). Fill from the pond has been placed along one of its banks (see photo 18). S/L 23 off Regal Ridge Circle has a path leading into the CE that ends at a fire pit (see photo 22). Woody debris is also located within the CE boundaries on S/L 23.

Photo 9: NE into CE from SL 21.

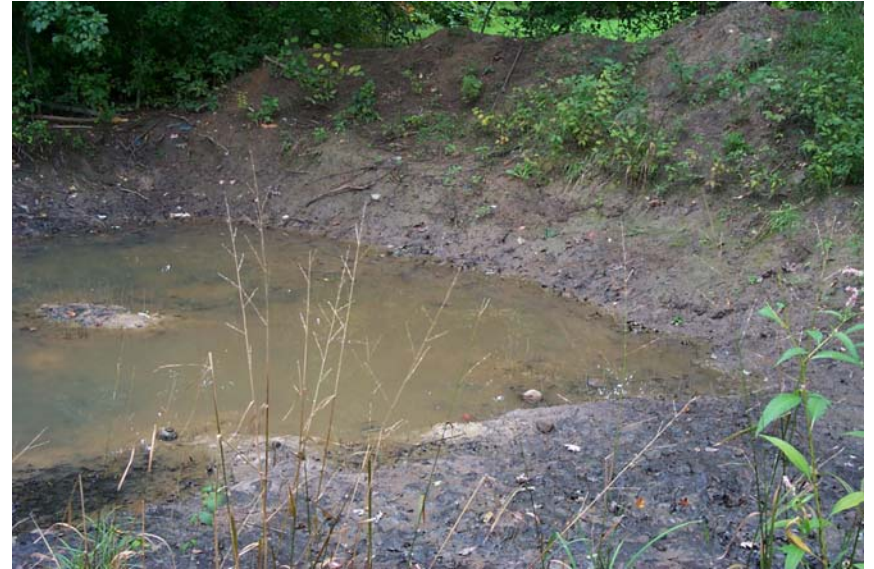
Photo 14: E to dug out pond in CE, behind SL 22.

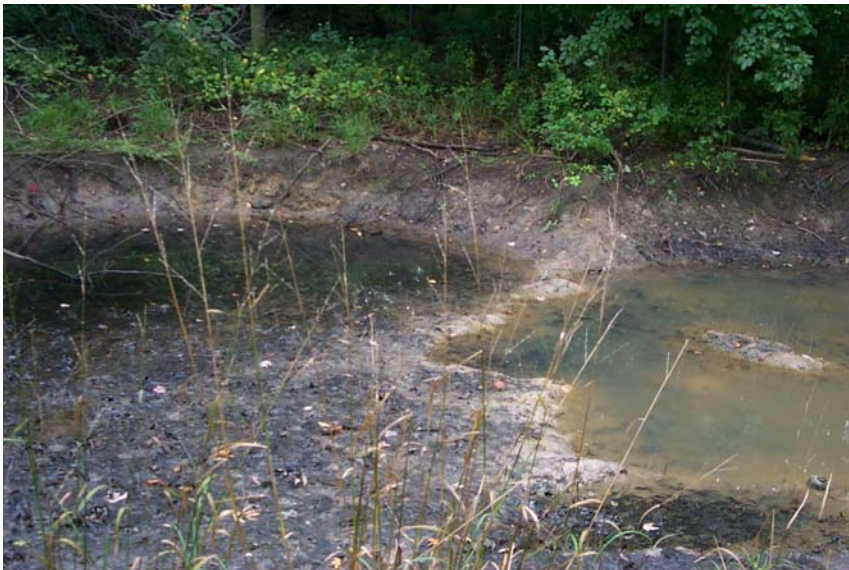
Photo 15: Dug out pond with berm and drainage basin in CE off SL 22.

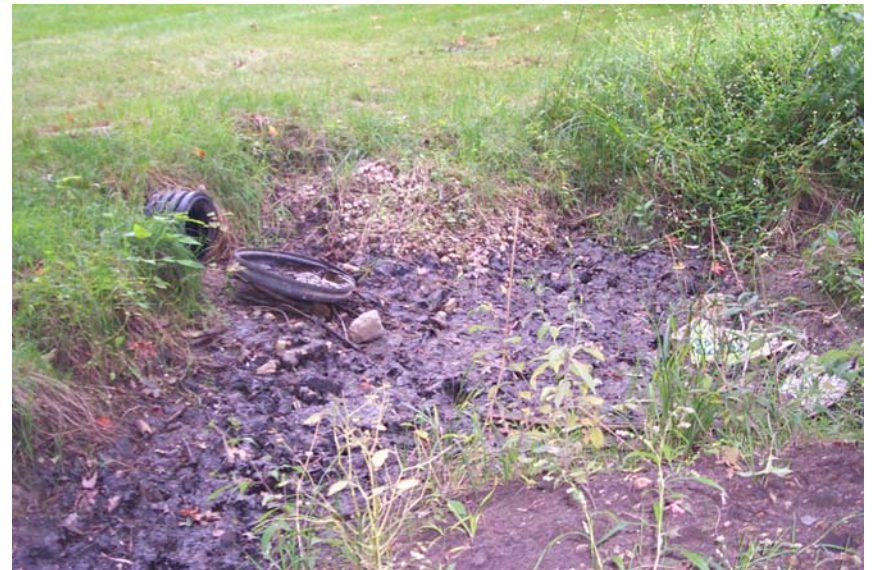
Photo 16: Drainage from SL 22 into drainage basin in CE.

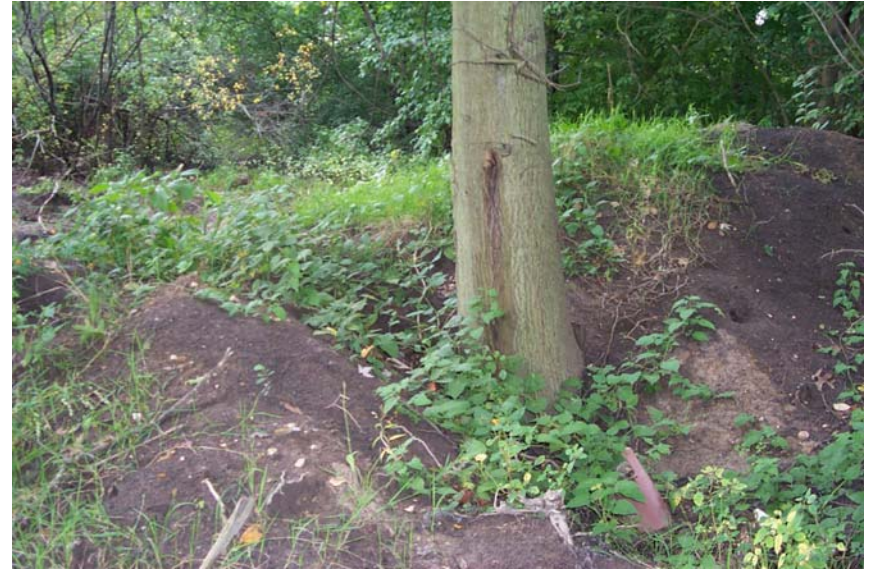
Photo 18: Fill from dug out pond along its edge in CE, off SL 22.

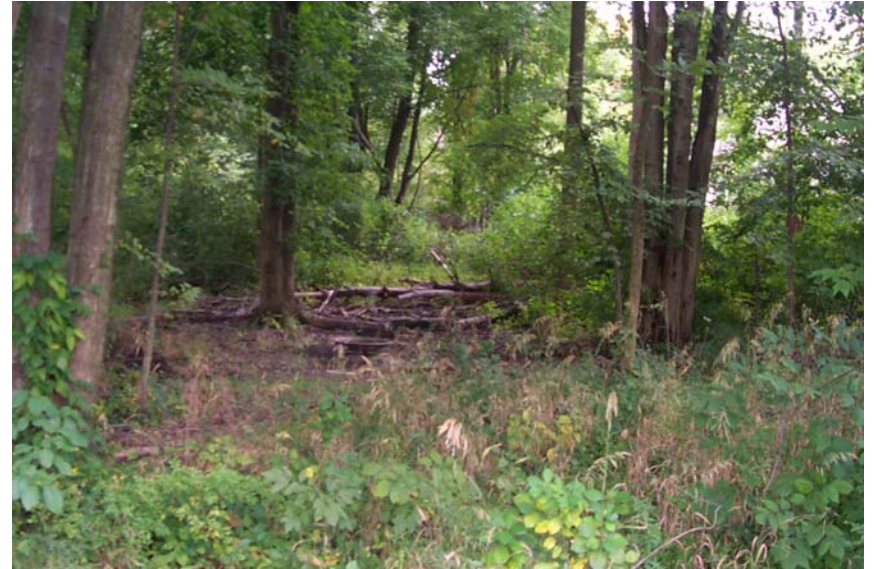
Photo 22: SW into CE at fire pit and debris from SL 23.

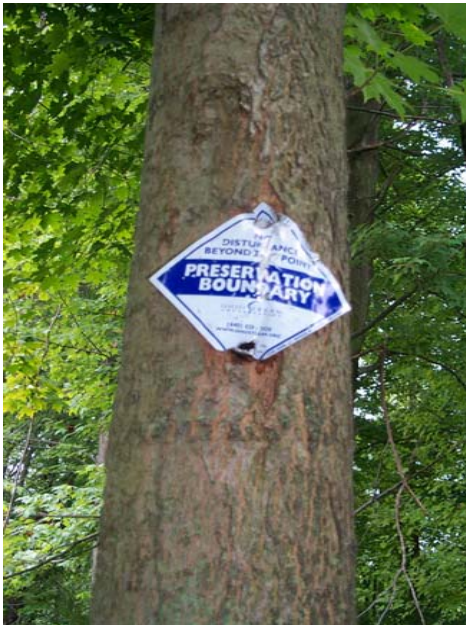
Photo 23: Damaged sign on SL 23.

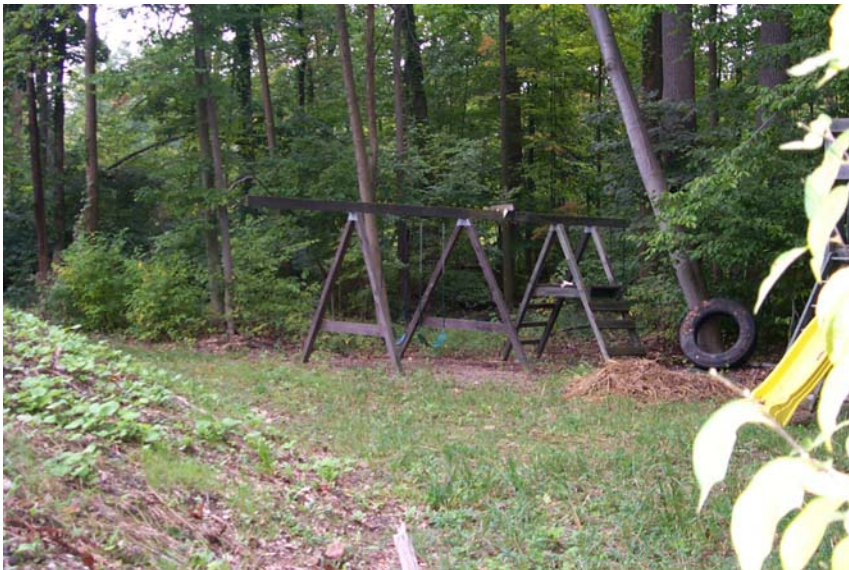
The graded slopes behind S/Ls 51-62 on River Run Drive are extremely steep (see photos 27-29). This not only made it difficult to walk along the steep hills incorporating the backyards of these lots, but raises concern of excess runoff flowing into the CE. S/L 52 has a swing set that encroaches the CE (see photo 27). S/L 54 has mowed grass, grass clippings, a swing set, children's toys, and a bench at least 50 feet into the CE that abut the stream (see photos 29 and 30). S/L 59 has a cleared path leading to the stream within the CE (see photo 31). The model home on S/L 62 has fill and debris along the back slope leading into the CE (see photo 32). Construction from S/L 121 on Whispering Woods Drive is allowing silt to flow into the stream within the CE on the SW corner of the property (see photo 38).

Photo 27: SSE along CE to right, SL 52 to right, swingset in CE.

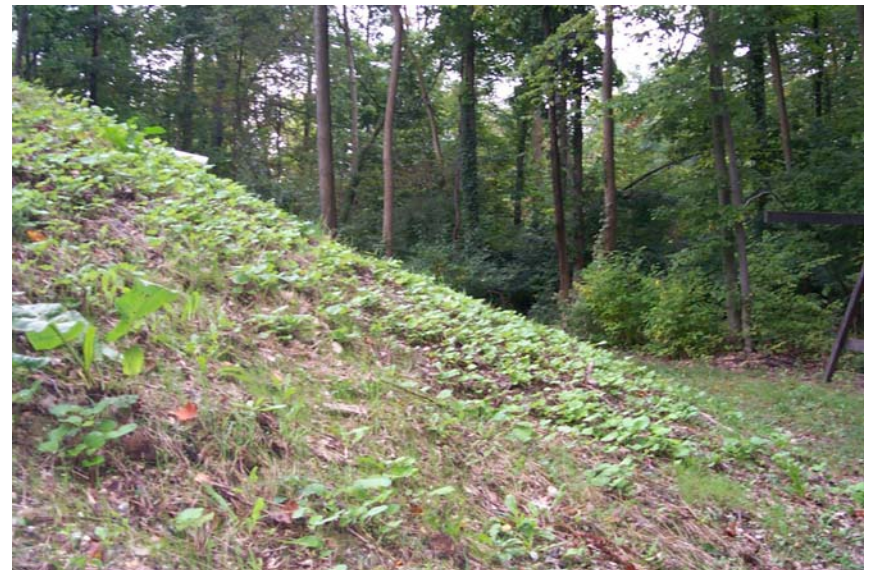
Photo 28: SW to CE off SL 52, pipe and steep grade into CE.

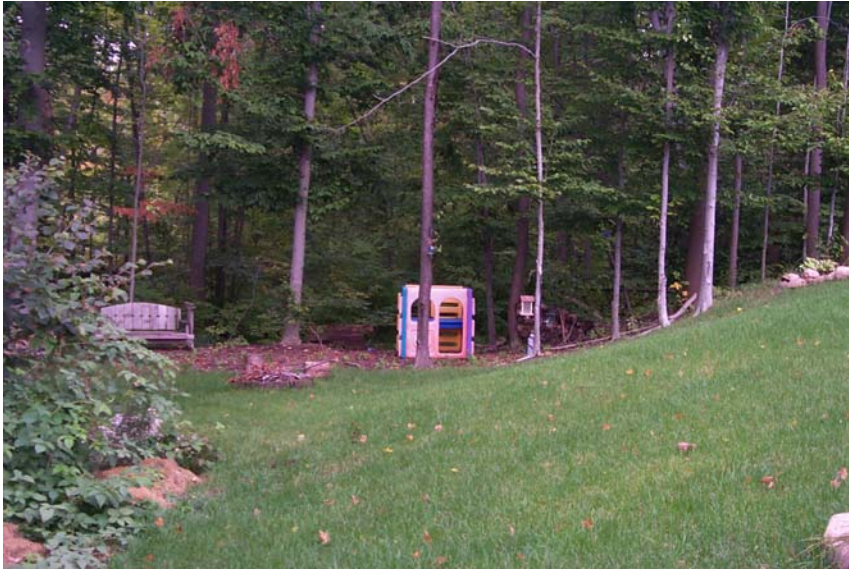
Photo 29: NNW along CE to left, SL 54 to right, encroachment.

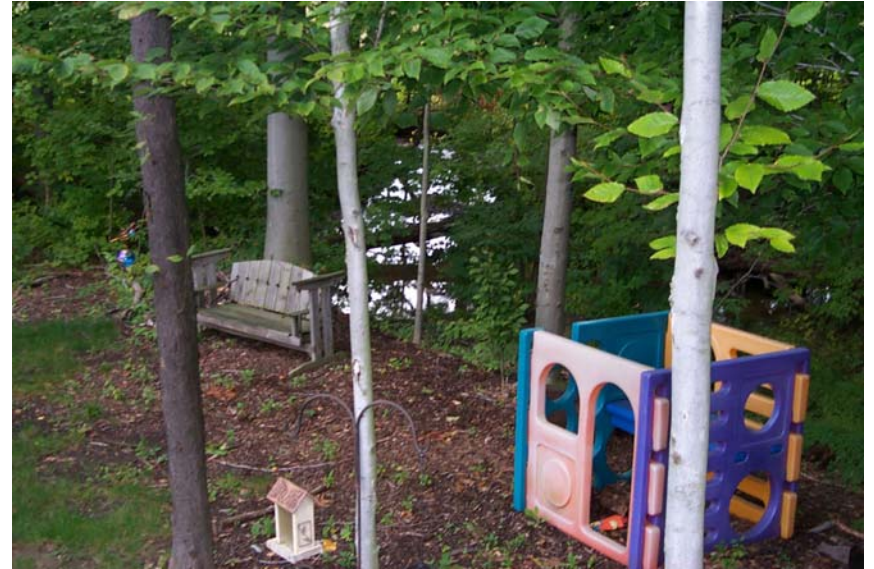
Photo 30: W into CE from SL 54 to encroaching bench on stream.

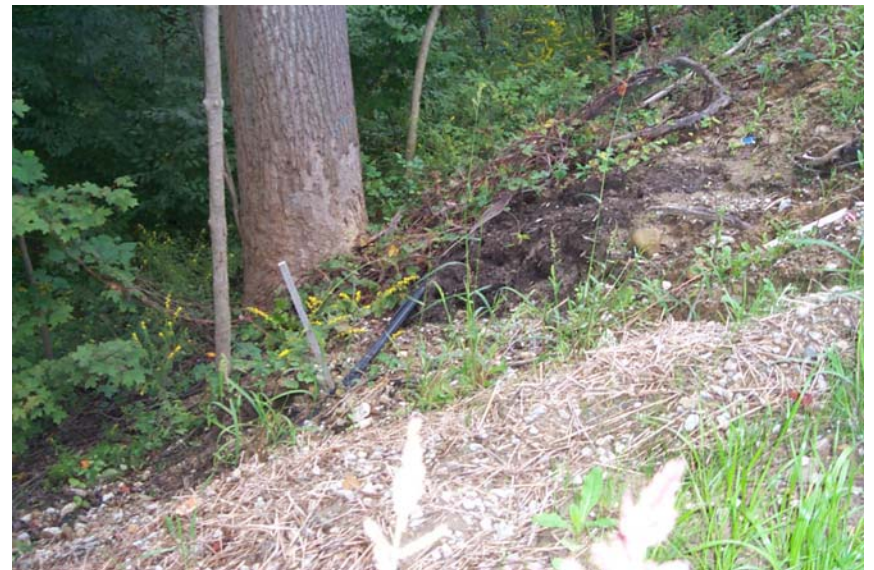
Photo 32: NW along CE to left, fill flowing into CE from model on SL 62 to right.

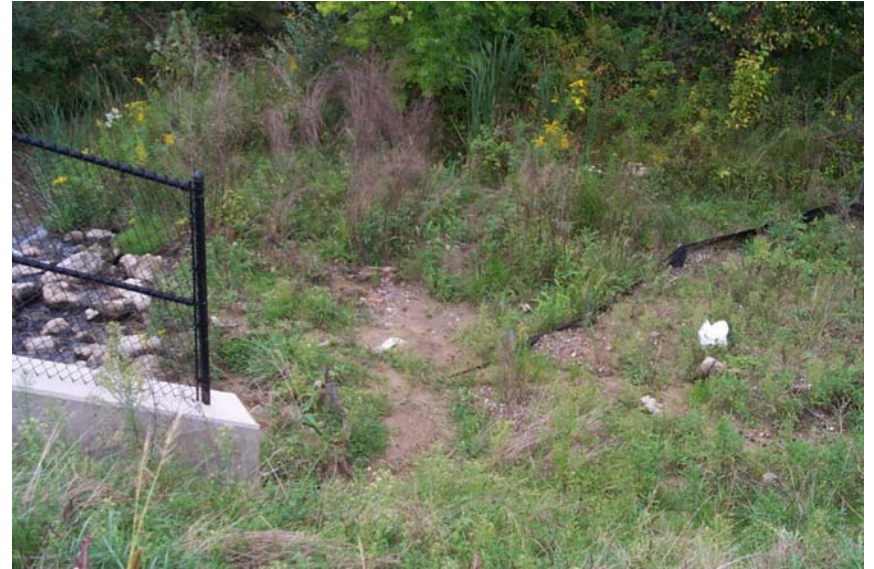
Photo 38: W to CE from Whispering Woods.

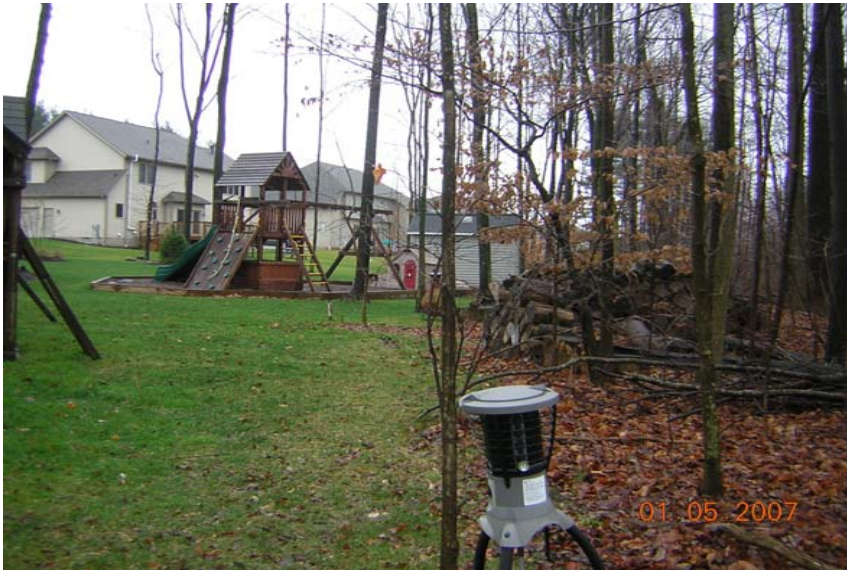
S/Ls 37, 38, 40, and 41 appear to have encroachments via swing sets and mowed grass

(see photos 41-44). A newly built red shed on S/L 42 looks to be encroaching as well, but it is difficult to tell since the CE bows south into the useable property and then turns north again (see photos 44-45). A picnic table and fire pit are located next to the stream within the CE on S/L 43 (see photo 46). S/L 44 is undergoing construction of an outdoor patio (see photos 47 and 49). The patio itself may not be encroaching, but the material for it is. Hundreds of pavers are laid out within the CE (see photos 48 and 50). These pavers will prohibit the growth of vegetation this summer in the CE if they are to remain there for an extended period.

Photo 41: View SSW from SL 37 to SL 38, encroached CE.

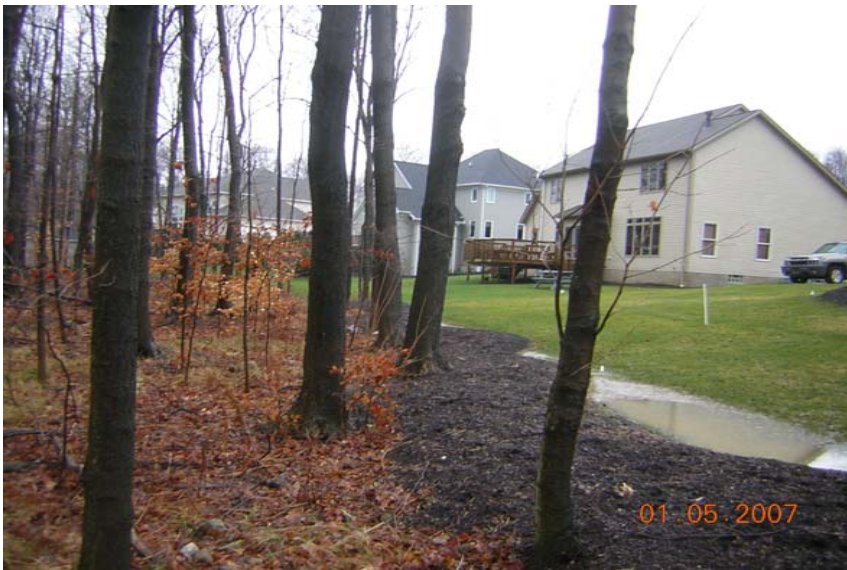
Photo 43: View NE of encroaching landscaping on SL 40.

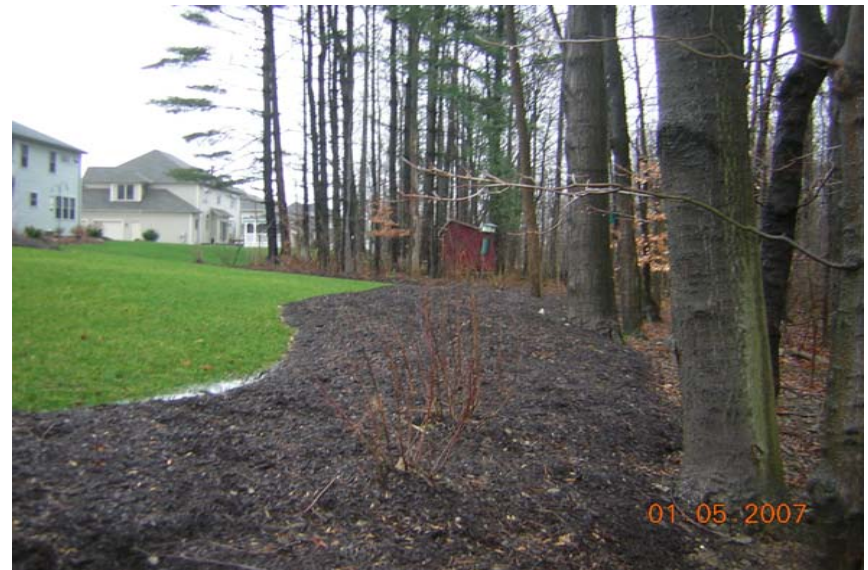
Photo 44: View SW of encroachment in SL 41. Tree to left in background has OSP sign. CE to right of it.

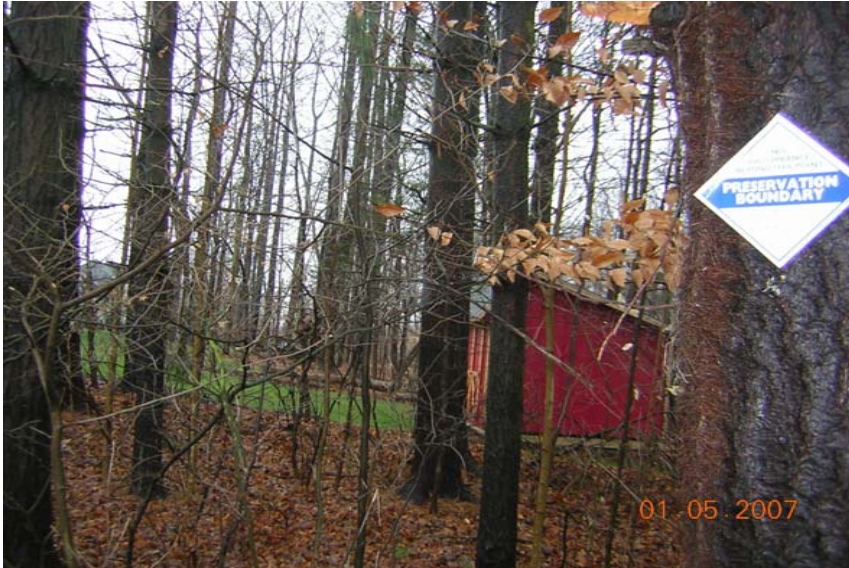
Photo 45: View SW along CE on SL 42.

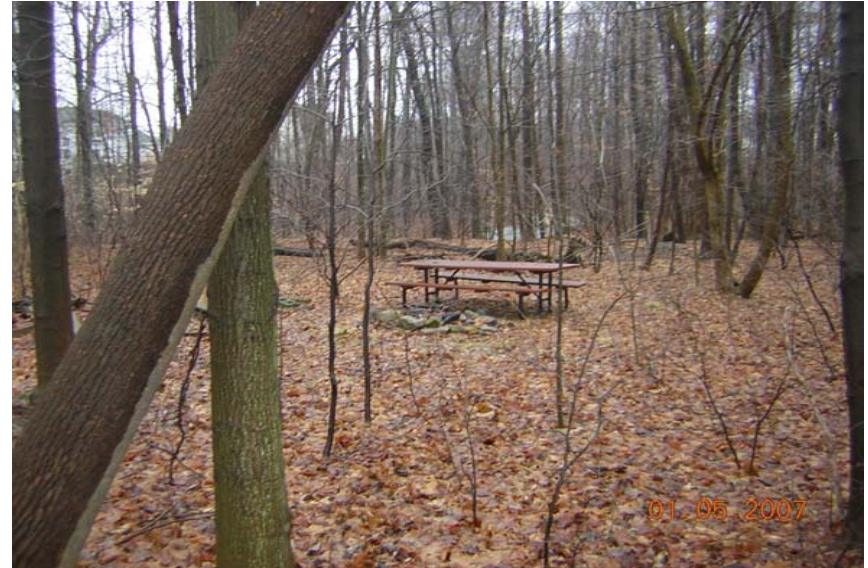
Photo 46: View NW of picnic table and fire pit with stream behind on CE on SL 43.

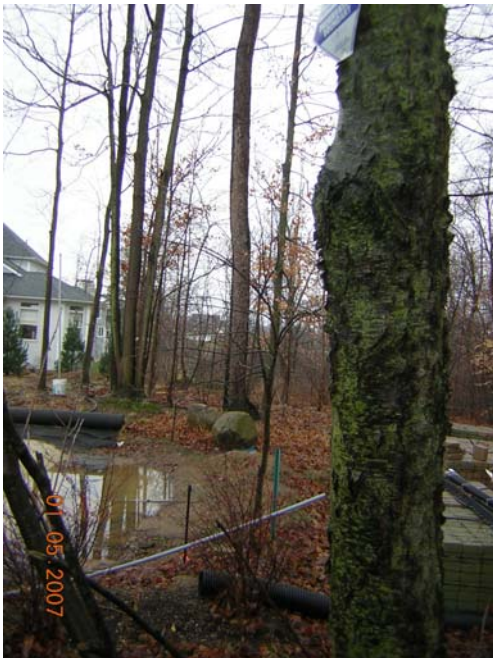
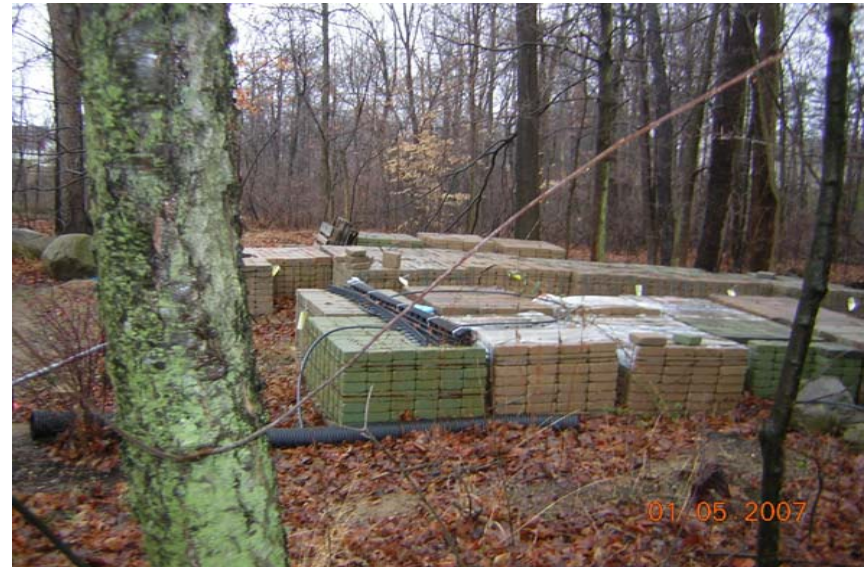
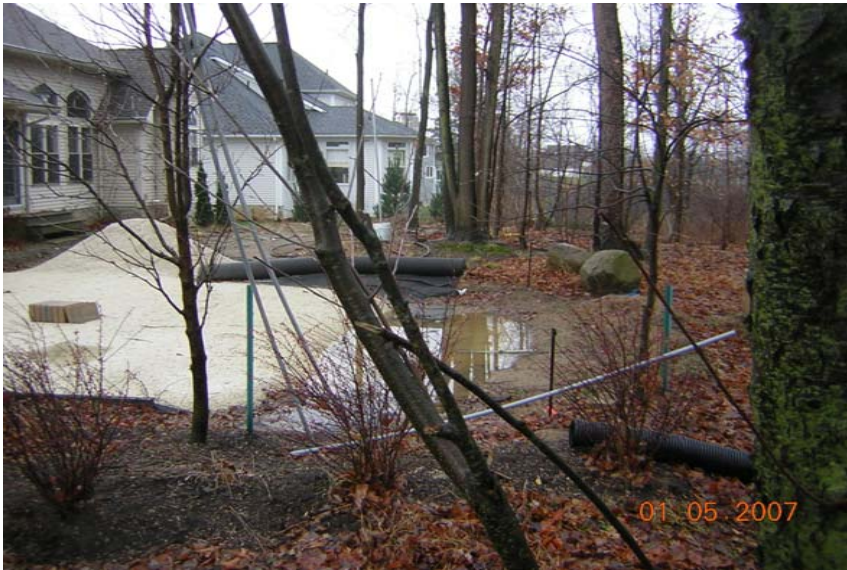
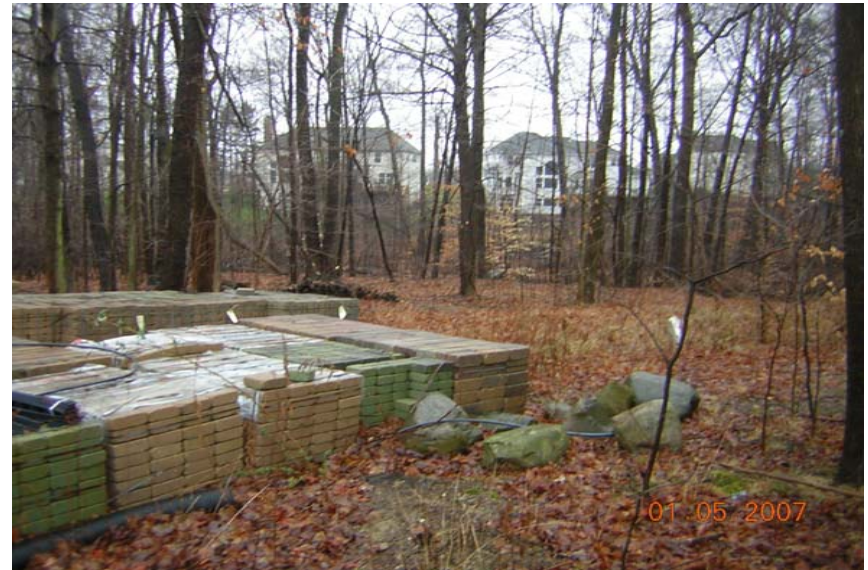
Photo 47: View SW along CE on SL 44 of patio construction.

Photo 48: View W within CE on SL 44 of pavers.

Photo 49: View SW along CE boundary and patio construction on SL 44.

Photo 50: View NW into CE on SL 44 of pavers.

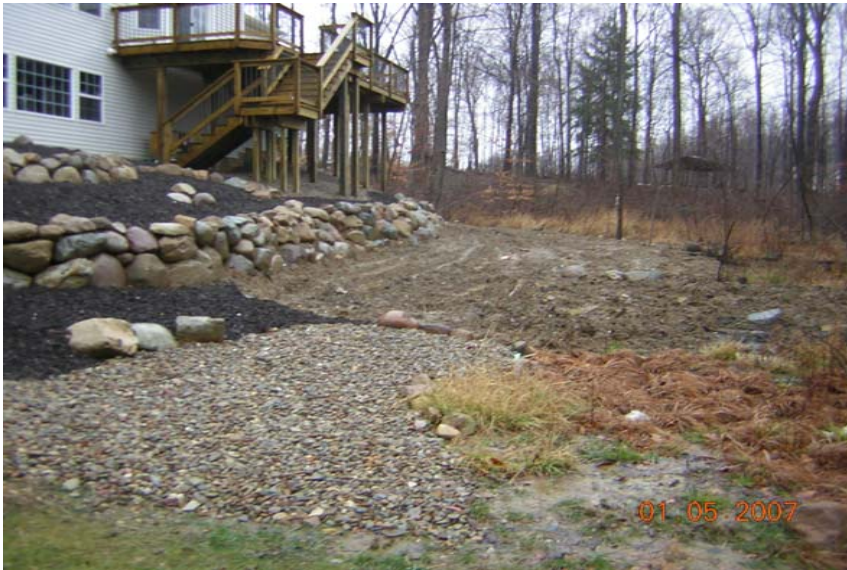
A previous visit to S/L 102 had been prompted by the homeowner due to storm damage and fallen trees. She had requested permission to chop the wood of the fallen trees to neaten up the area as well as cut down one tree that could fall on her house if it were to succumb to the same fate as the other fallen trees. This visit showed the tree had been taken down and chopped wood was left in the CE as requested for habitat (see photos 64-65). There is new landscaping directly behind the house that has left muddy residue along the CE boundary (see photos 61-62).

Photo 61: View N along CE on SL 102. New landscaping.

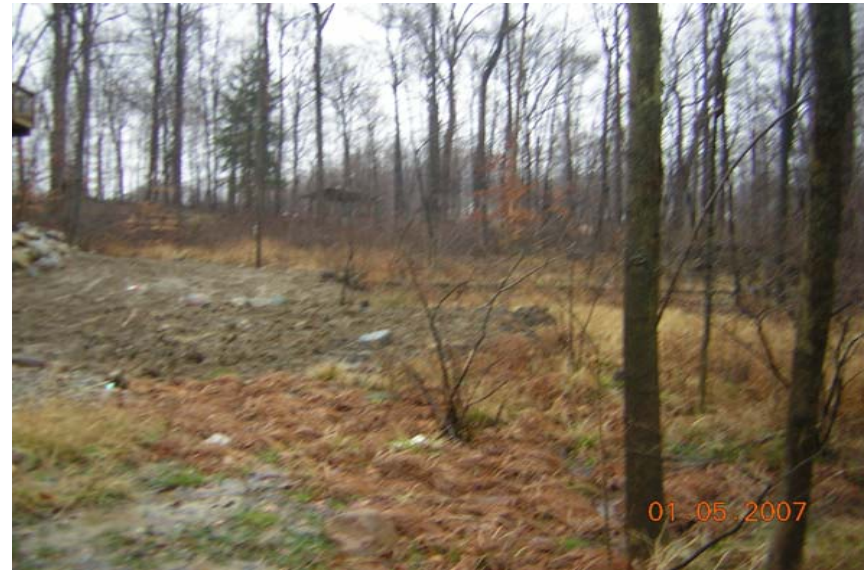
Photo 62: View ENE along CE on SL 102. Muddy residue from landscaping.

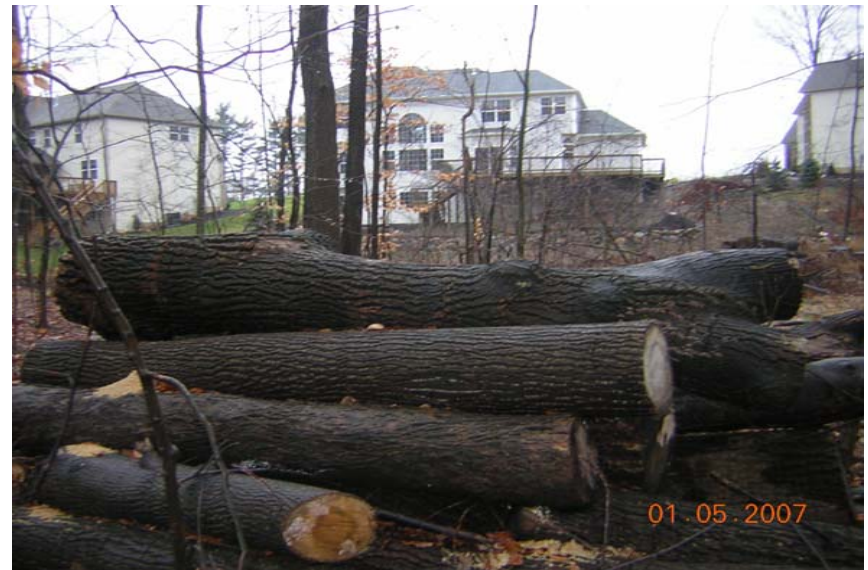
Photo 64: View NW at chopped logs in CE on SL 102.
