# Ohio Stream Preservation, Inc. Conservation Easement Inspection Report

Site Century Mine

Date of Site Visit December 12, 2012 Long: 81°01'40.28" W Lat: 39°53'40.61" N

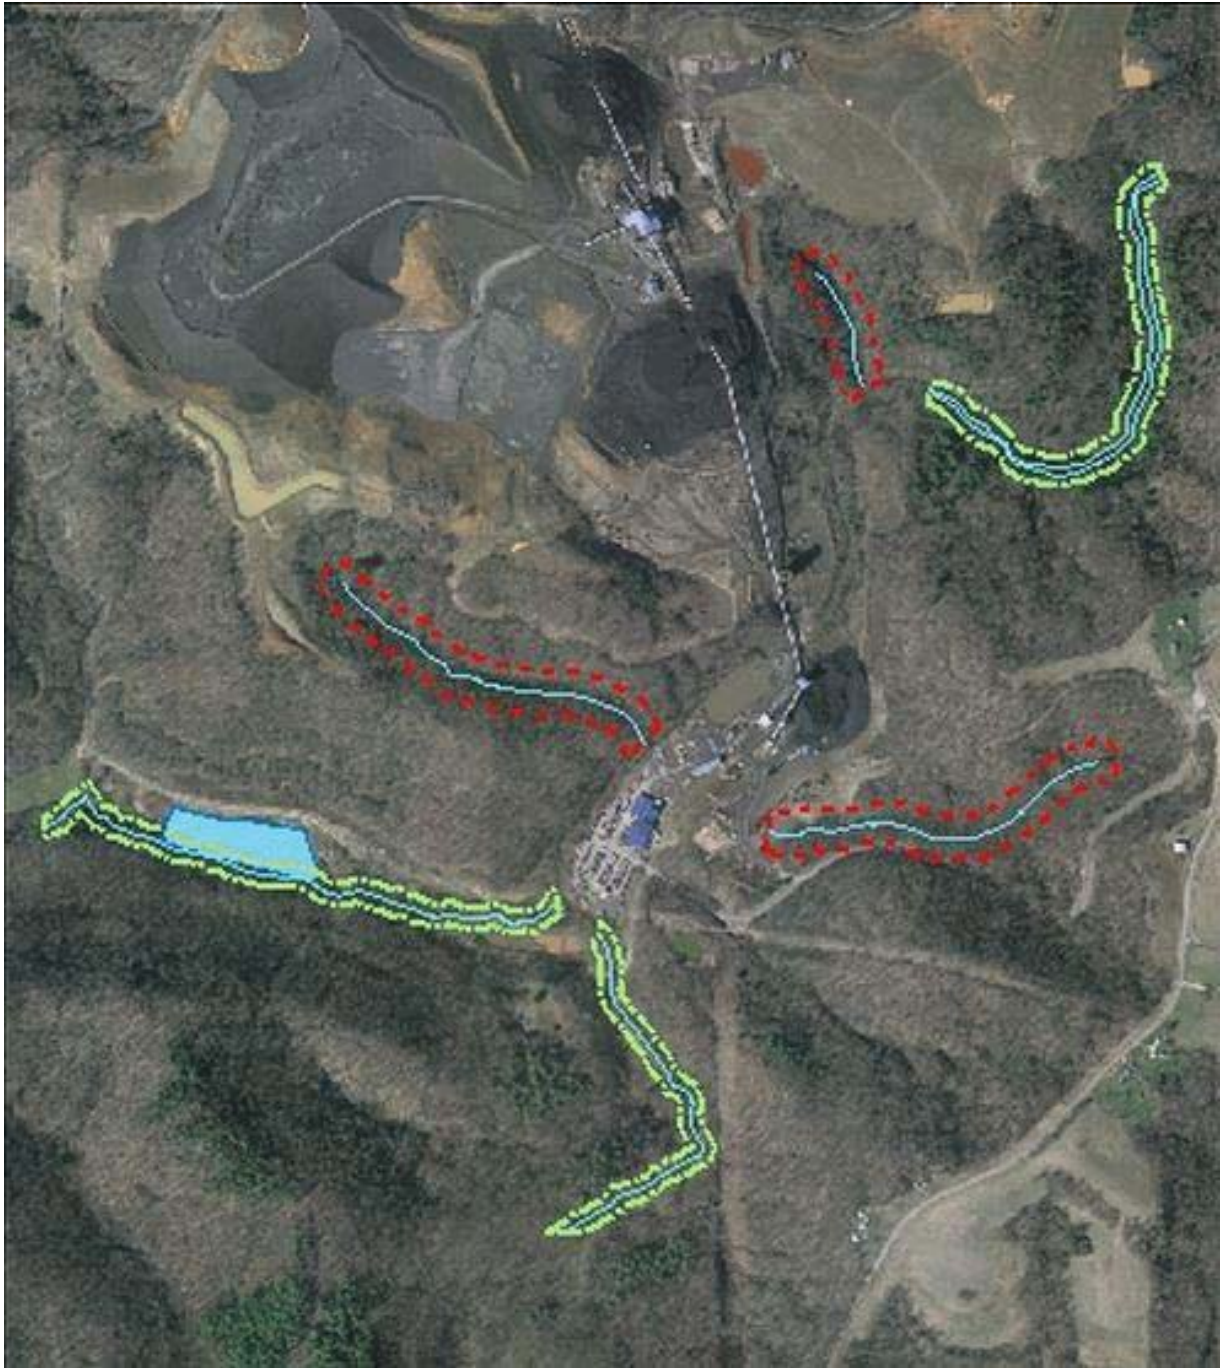
2012 Century Mine aerial

Assessment performed from satellite imagery dated 08/2012. Conservation Easement area appears in good condition, no clearing evident within easement. Operating coal mine surrounding easement.

No impacts apparent within conservation easement area.
