Ohio Stream Preservation, Inc. Conservation Easement Inspection Report

Site Morgan Court Industrial

Date of Site Visit January 10, 2013 Long: 81°52'33.52" W Lat: 41°17'29.30" N

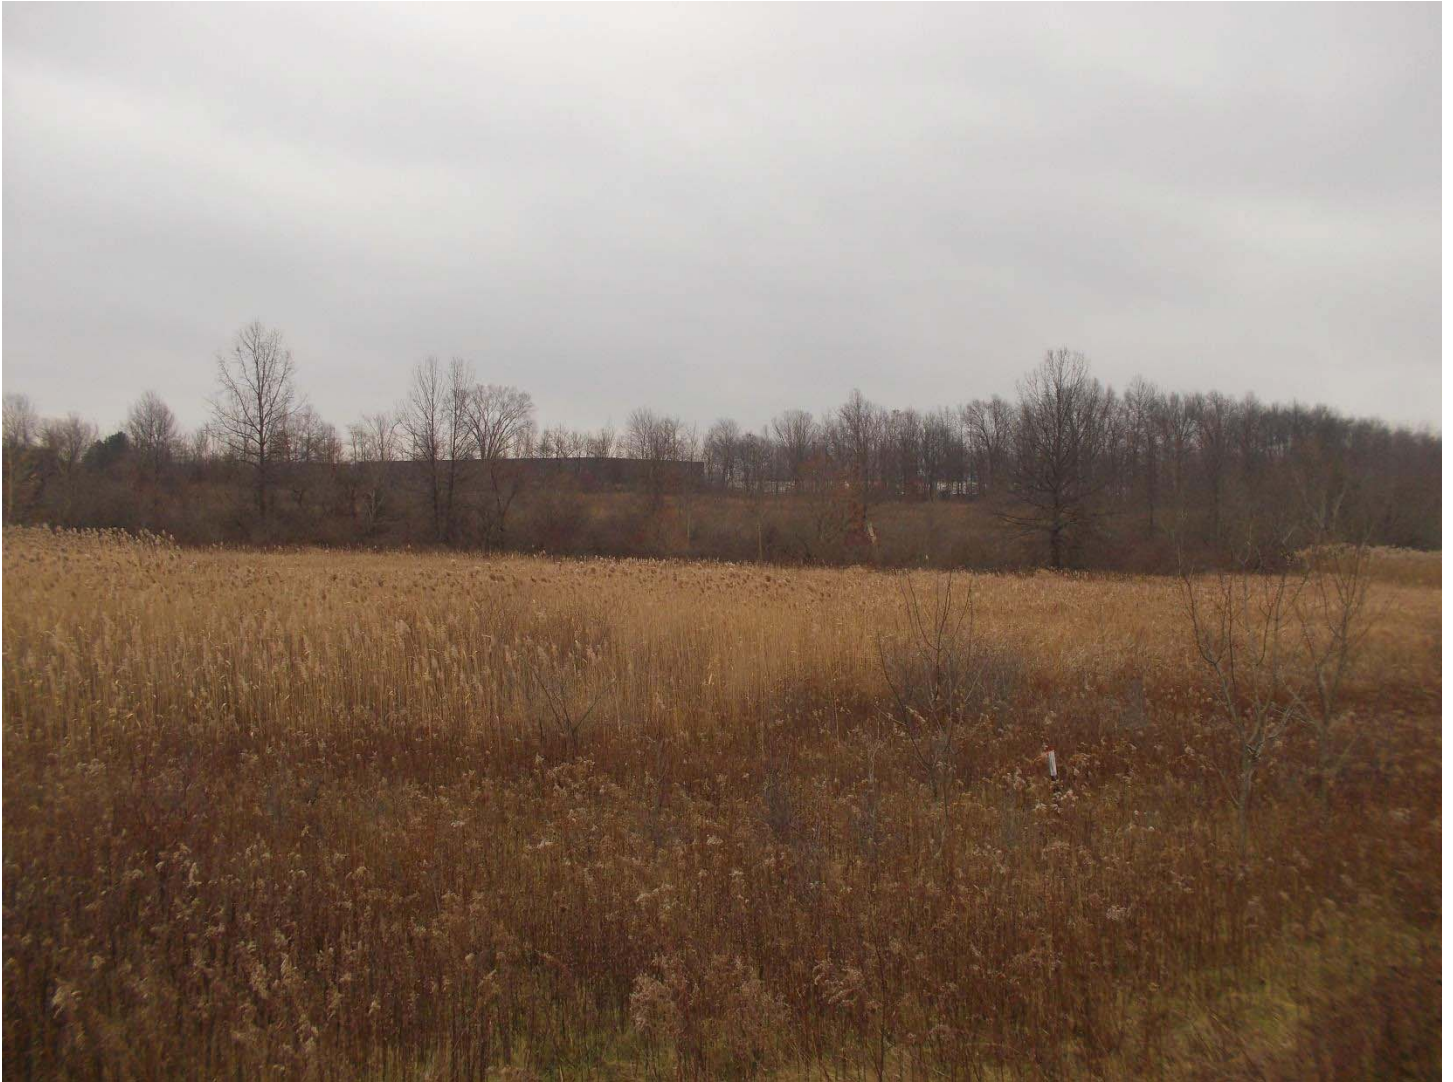
Site Photograph(s):

Signs of recreation vehicle use (ATV trails) were noted along the railroad tracks in the eastern portion of the conservation easement as well as western portion of the easement.
