Ohio Stream Preservation, Inc. Conservation Easement Inspection Report

Site Frostwood Farms Subdivision

Date of Site Visit February 5, 2013 Long: 81°13'46.40" W Lat: 41°21'38.39" N

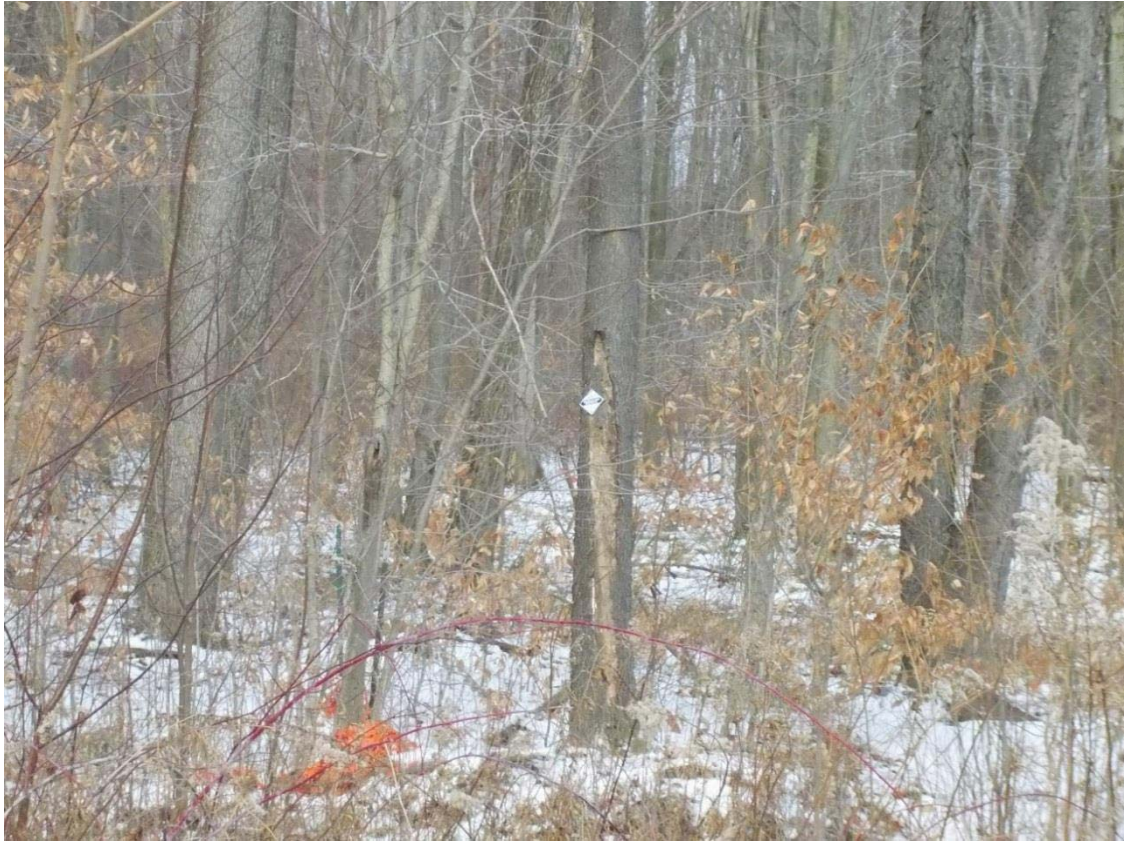
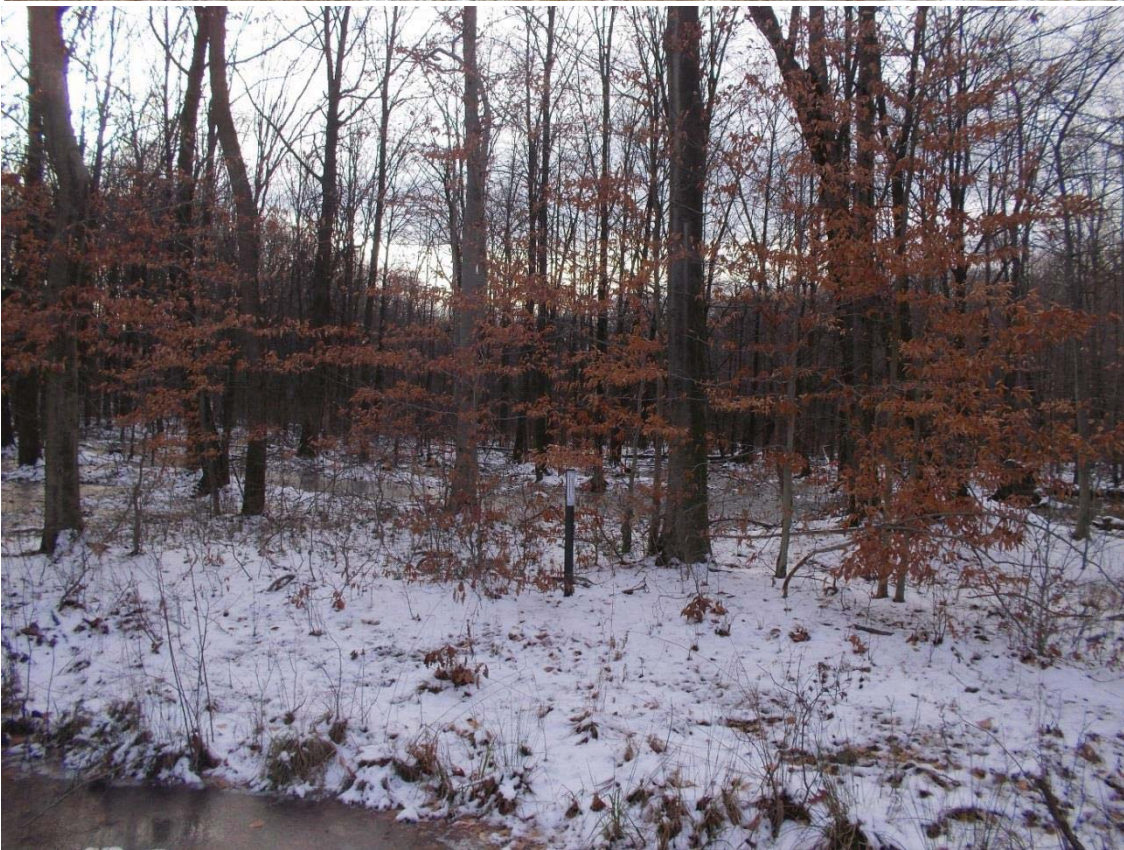
Site Photograph(s):

No encroachments were observed during the 2013 site visit. Signs marking the easement are clearly visible.
