BASELINE DOCUMENTATION REPORT

**FOR
EMERALD VALLEY BUSINESS PARK
VILLAGE OF GLENWILLOW, OHIO**

September 29, 2006

Photo Journal – September 2006
Emerald Valley Business Park

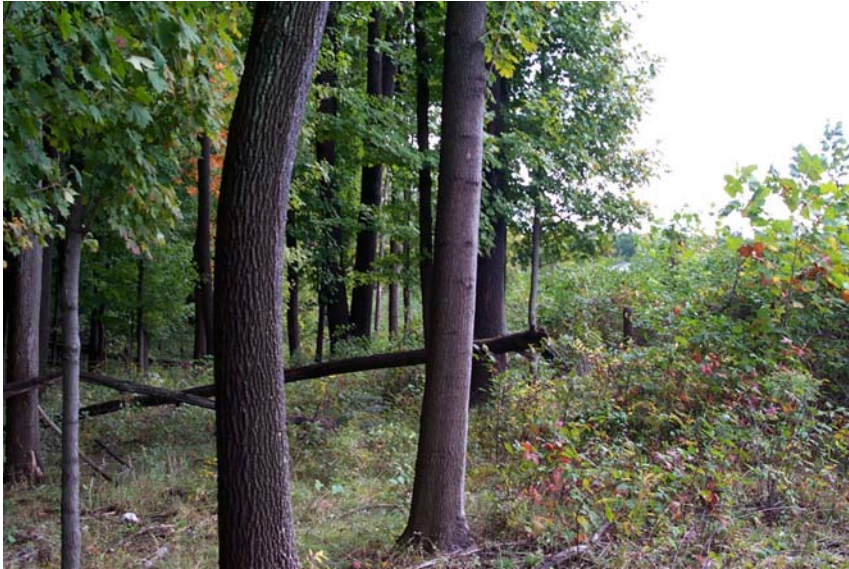
The southern boundary of the CE between the two lobes runs along a thick shrub area uphill to a parking lot (see photos 1-2). The western and southern edges of the east (right) lobe of the CE are along mowed grass or shrubby areas behind parking lots for other building (see photos 23-24). No encroachments were seen in these areas.

Photo 1: Looking E along Conservation Easement Boundary ("CEB"), CE to left

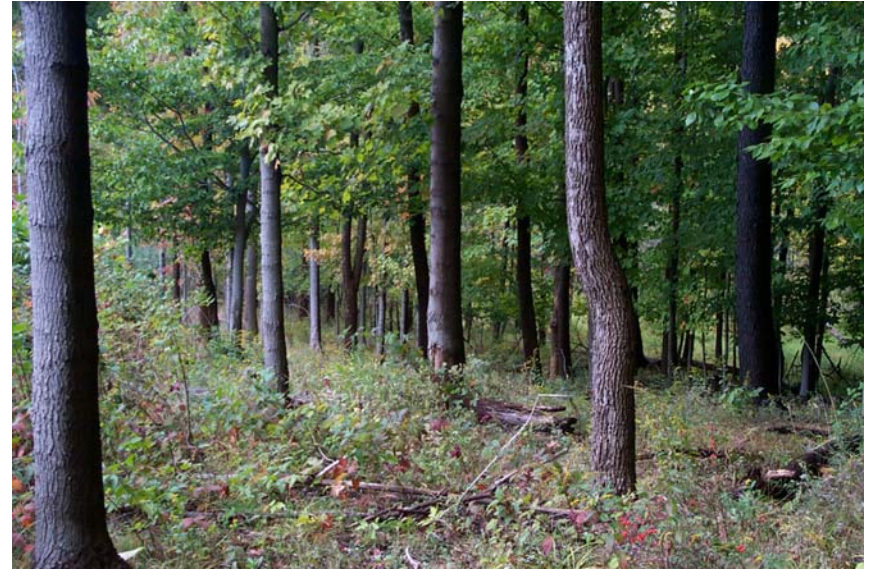
Photo 2: Looking W along CEB, CE to right

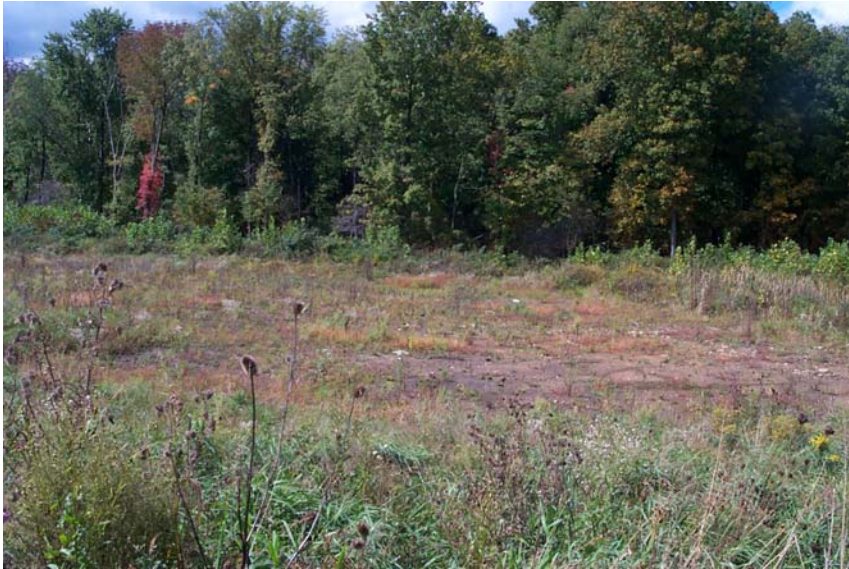
The shape of the CE is similar to a shallow horseshoe. The two outer lobes of the horseshoe point to the south. The west (left) lobe CE boundaries were difficult to locate. They appear to be along a treeline, adjacent to scrub growth (see photos 5-8). Buildings have been proposed to be built in this shrubby area.

Photo 5: Looking SW into CE left lobe

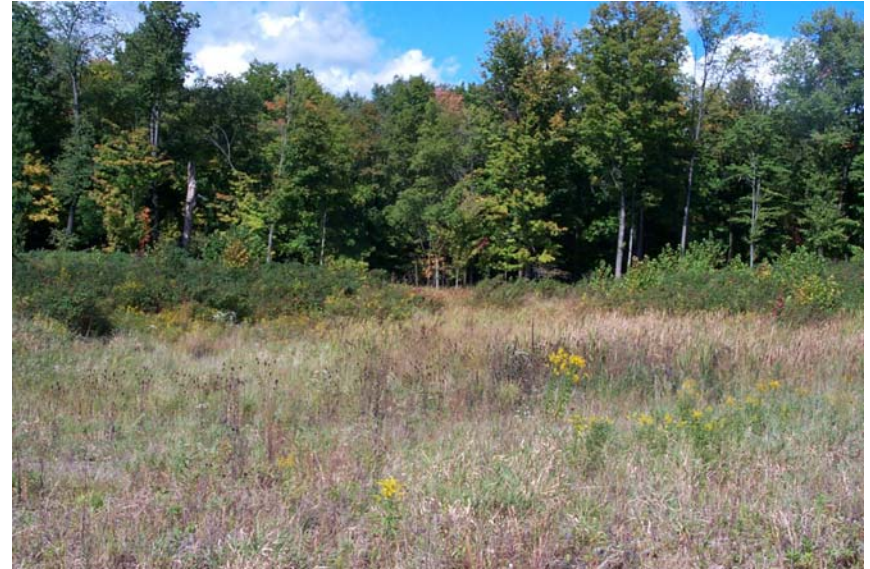
Photo 6: Looking NW to CEB with back to gazebo

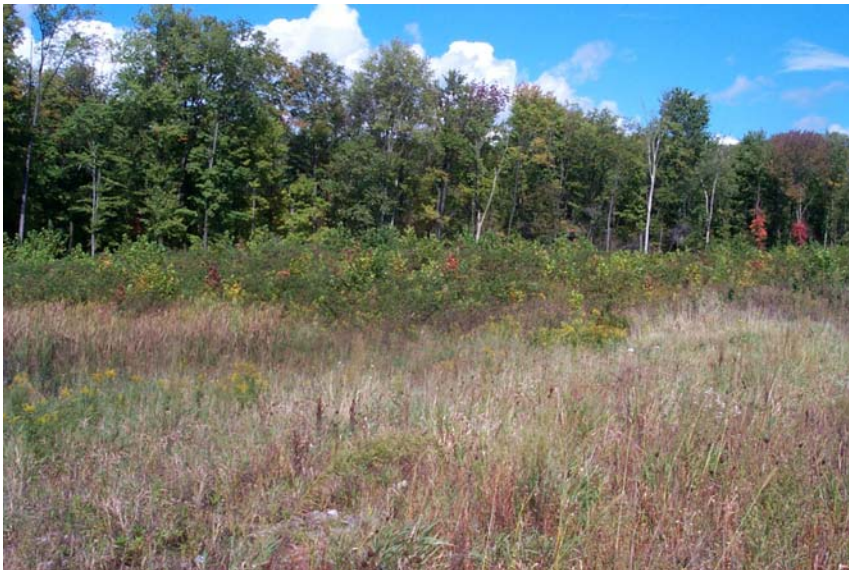
Photo 7: Looking N to CEB with back to gazebo

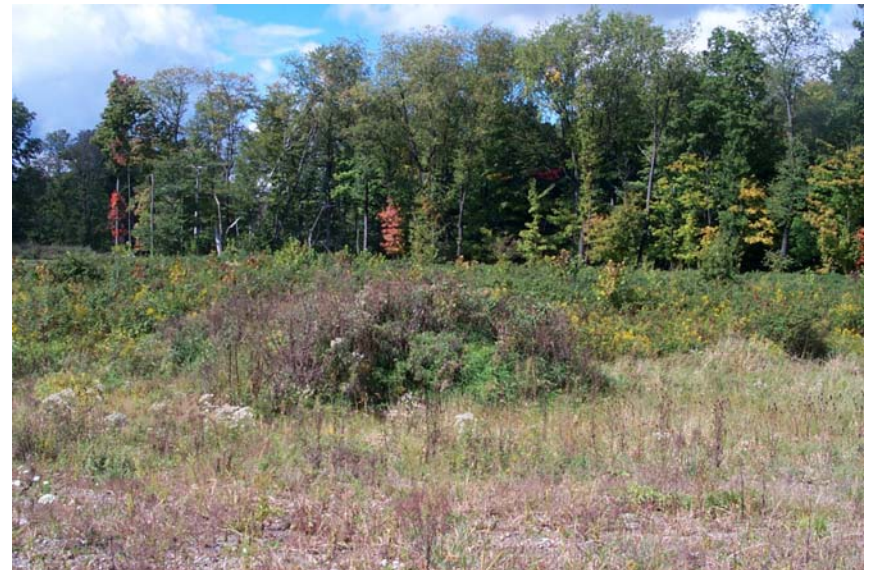
Photo 8: Looking W-NW to CEB with back to gazebo

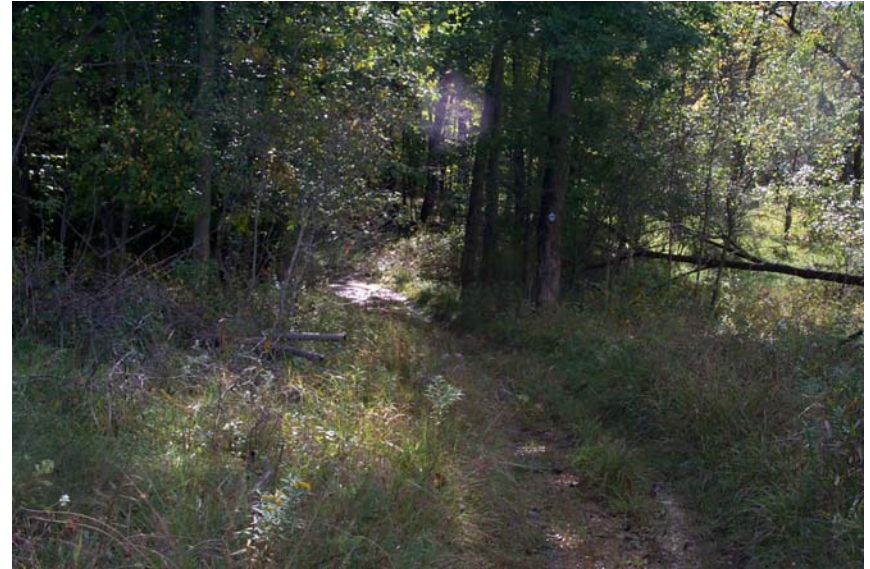
A possible encroachment occurs along the northern edge near the utility easement. There is a walking path leading into the woods near Tinker's Creek and the railroad tracks (see photo 18). The path appears to have been there a long time.

Photo 18: Looking S at path leading into CE near NW CE corner

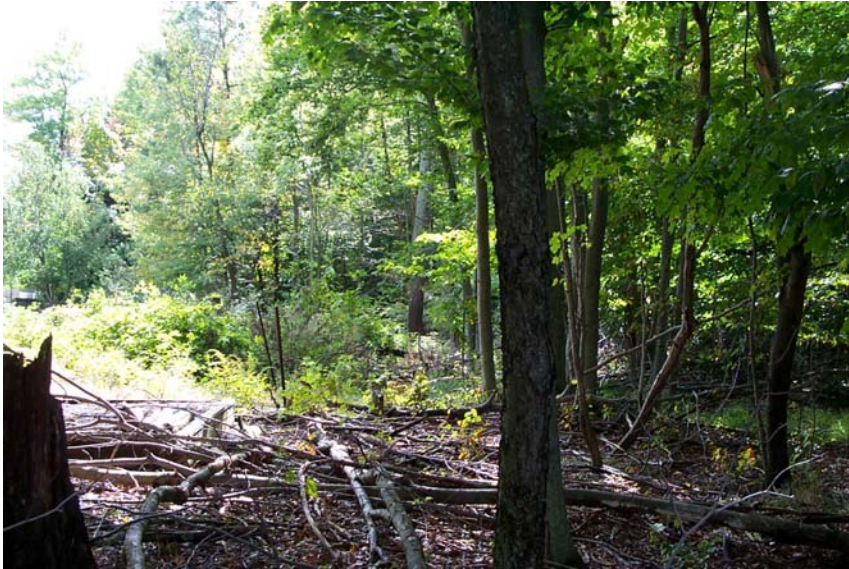
The eastern edge of the east lobe is bordered by approximately 12 residential properties. An old chainlink fence spans most of this area. A couple of encroachments were observed. One was at a dark brown house (possibly S/L 59). This property had piles of brush and branches within the confinements of the CE (see photo 21). A break in the chainlink fence of another property (possibly S/L 57) appears to be used for access to mow within the CE. This mowed area consists of approximately 20 ft by 12 ft (see photo 22). A GPS unit is suggested to determine accuracy of the CE boundary line along this eastern edge.

Photo 21: Looking S along CEB, CE to right, encroachment of brush pile within CE

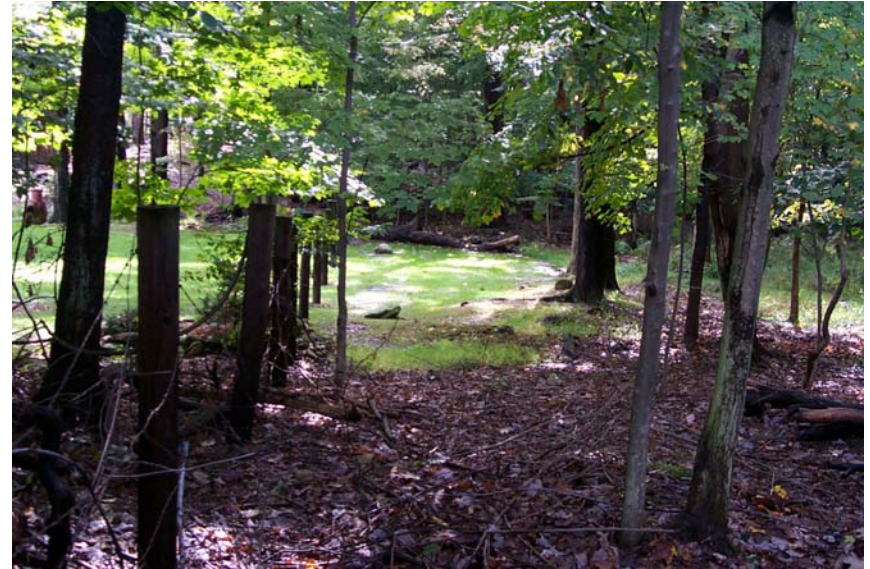
Photo 22: Looking S along CEB, encroachment of SL 57 beyond CE fence

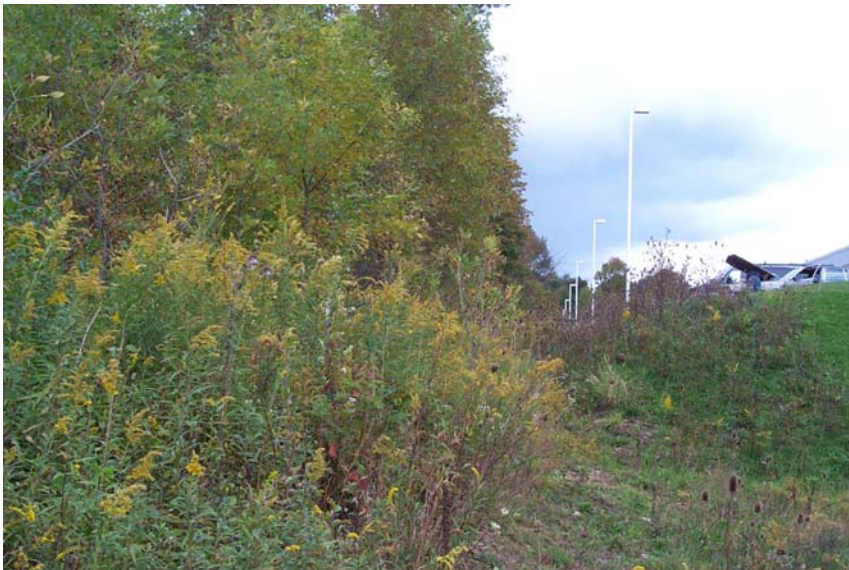
Photo 23: Looking E along CEB right lobe

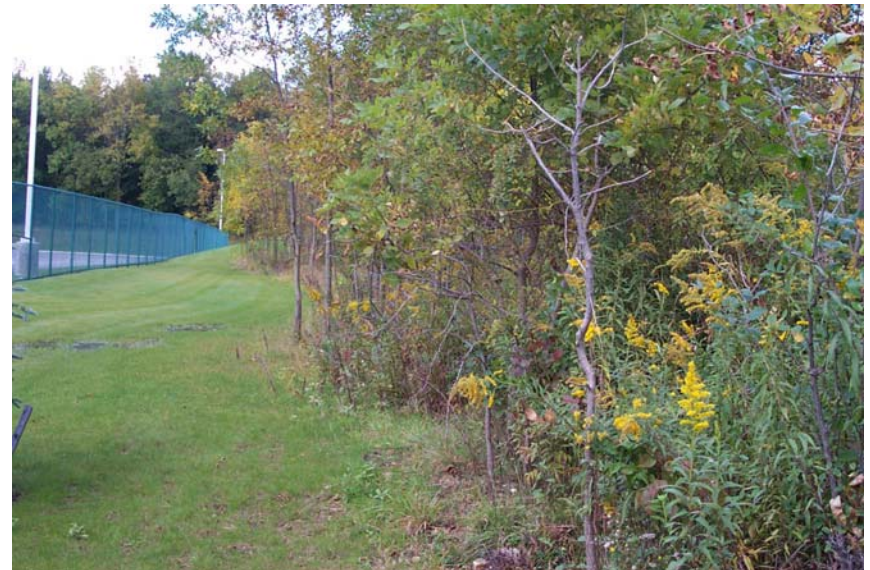
Photo 24: Looking N along CEB, W side of right lobe
