Ohio Stream Preservation, Inc. Conservation Easement Inspection Report

Investigator(s) Chagrin Valley Engineering, Ltd. **Site** The Woodlands

Date of Visit February 9, 2018 **Total Easement Acreage** 25

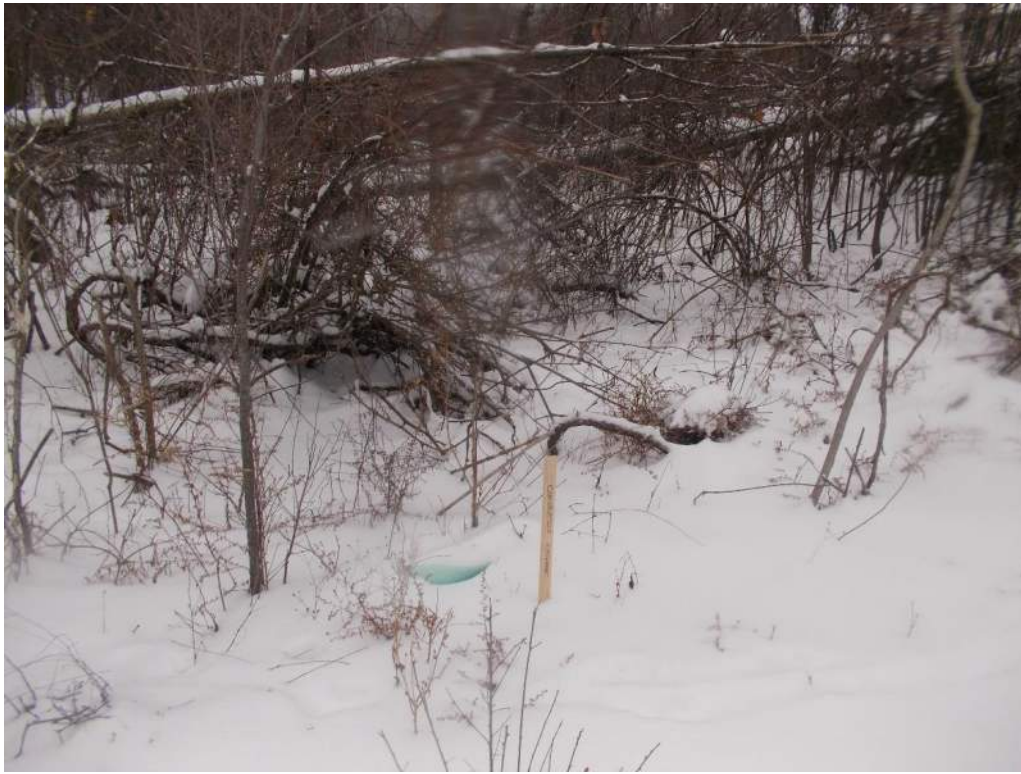
Date: February 9, 2018

Photo Direction: North

Feature: Boundary

Comments: Wooden stake placed by unknown, marking southern boundary of Preservation Easement 2 on 9007 Mulberry Pointe (SL 29). No Ohio Stream Preservation signs observed.

Construction on lots adjacent to Preservation Area 2 and 3 have impacted the conservation easement. These impacts include the clearing of woody vegetation and grading / soil mounding. CE signage along the northern and eastern boundary has been disturbed and or removed, making it difficult to discern the amount of impact. On SL 29 (9007 Mulberry Pointe) SL 30 (9009 Mulberry Pointe) construction has been completed. Both lots are located along the southern boundary of Preservation Area 2. Installation of additional signs is recommended for 2019.

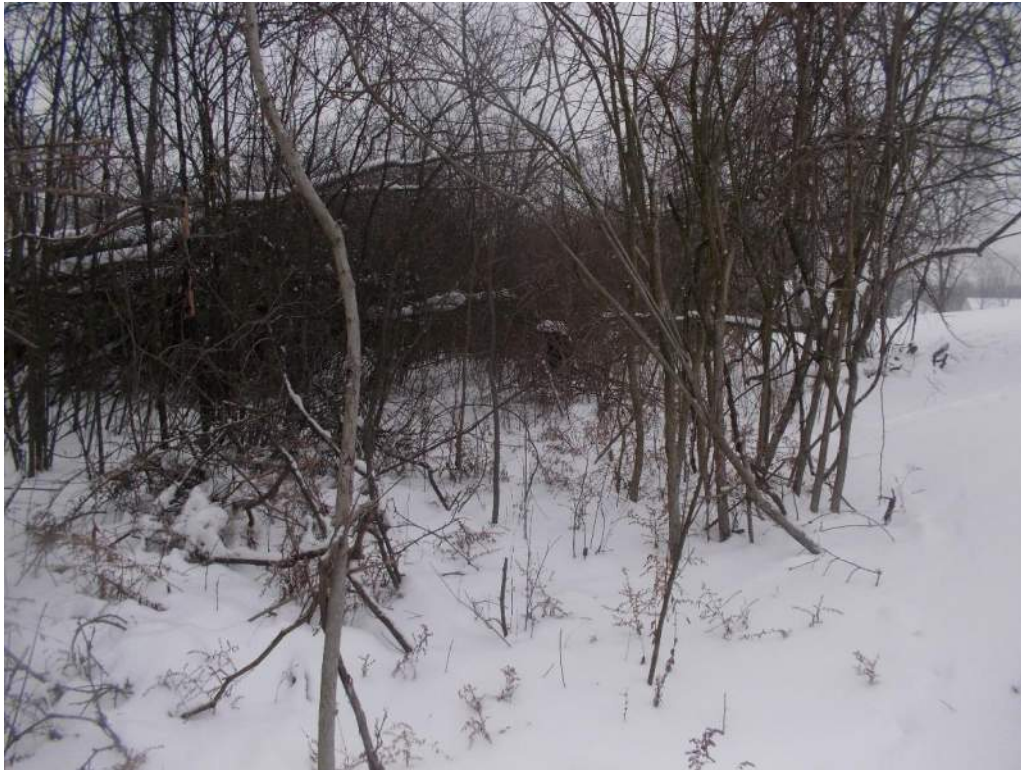
Date: February 9, 2018

Photo Direction: North

Feature: Boundary

Comments: Preservation Easement 1 boundary, view looking north.
