Ohio Stream Preservation, Inc. Conservation Easement Inspection Report

Site Stonebridge Creek

Date of Site Visit February 8, 2013 Long: 82°03'12.28" W Lat: 41°27'15.61" N

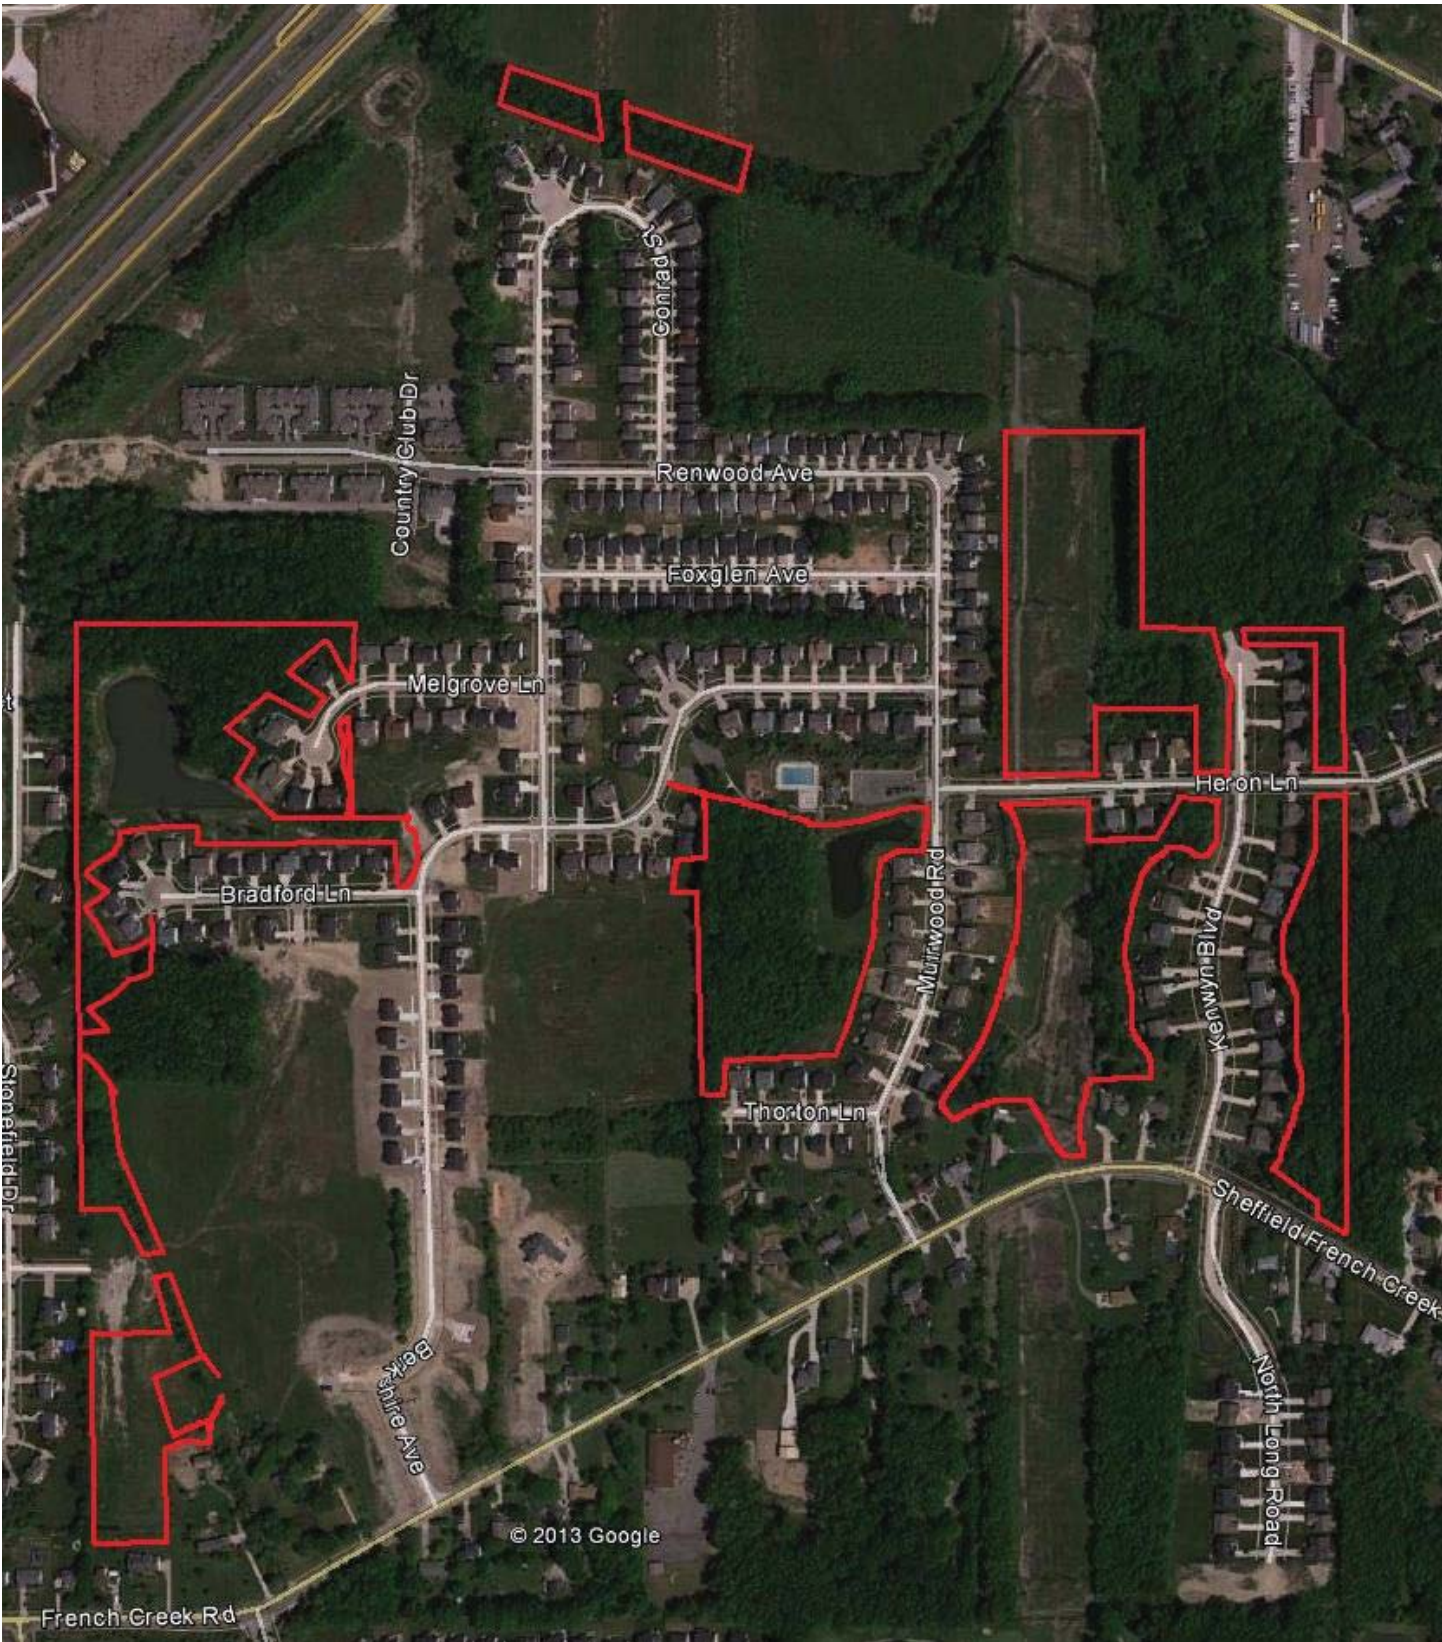
2012 Stonebridge Creek aerial

The Stonebridge Crossing easement has the same minor encroachment issues as noted in past monitoring reports. These minor encroachments include structures within the easement (sheds, play equipment), mowing and clearing of vegetation and sign removal. Signs need to be replaced in the eastern portion of the site along Bradford Ln. and Melgrove Ln. Signs also need to be replaced along Thorton Ln. and Muirwood Rd.

New homes have been constructed along Bradford Lane and Berkshire Avenue. As the subdivision development continues the far western areas of the conservation easement boundary will need to be located by survey and signs placed.
