BASELINE DOCUMENTATION REPORT

**FOR
LAKE FOREST ESTATES
MACEDONIA, OHIO**

SUMMIT COUNTY, OHIO

**September 15, 2006
January 5, 2007**

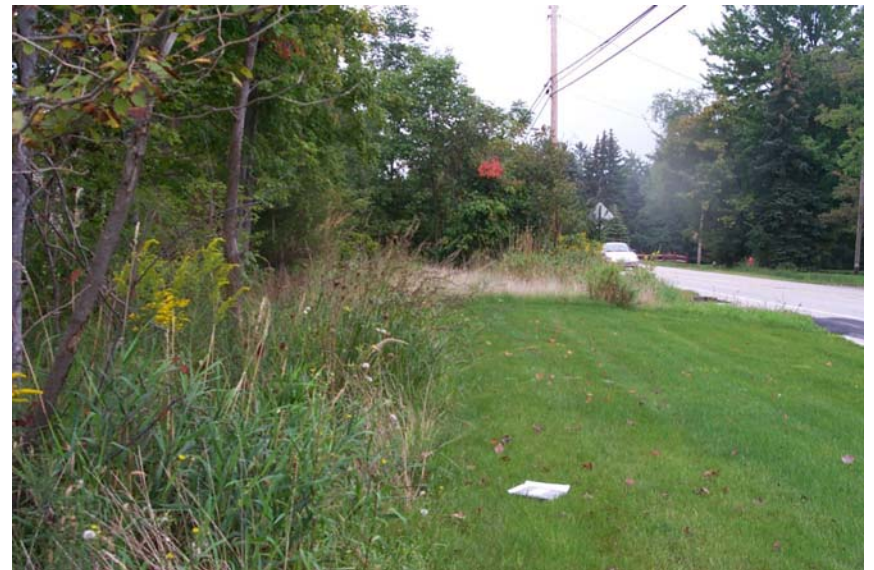
Photo 4: View SE along CEB and Valley View Rd.

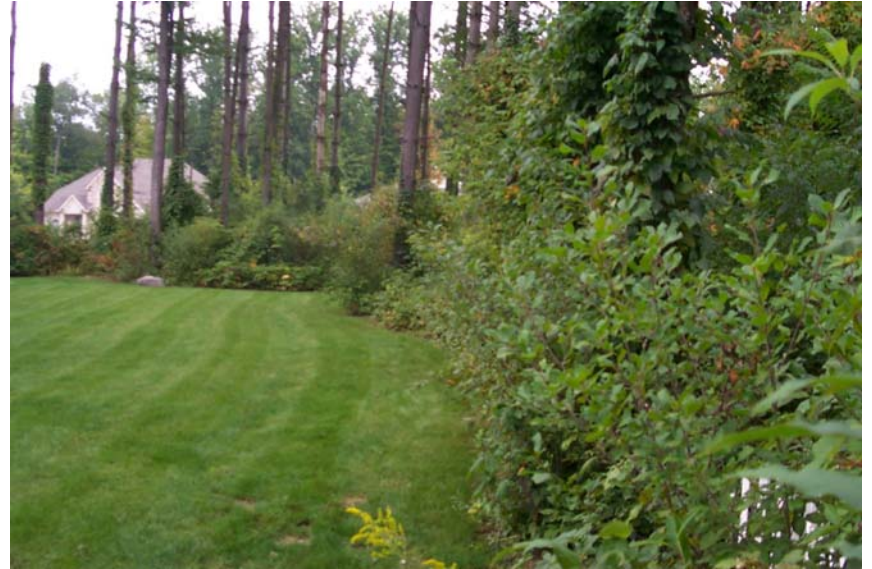
Photo 10: N along CE to right on SL 21.

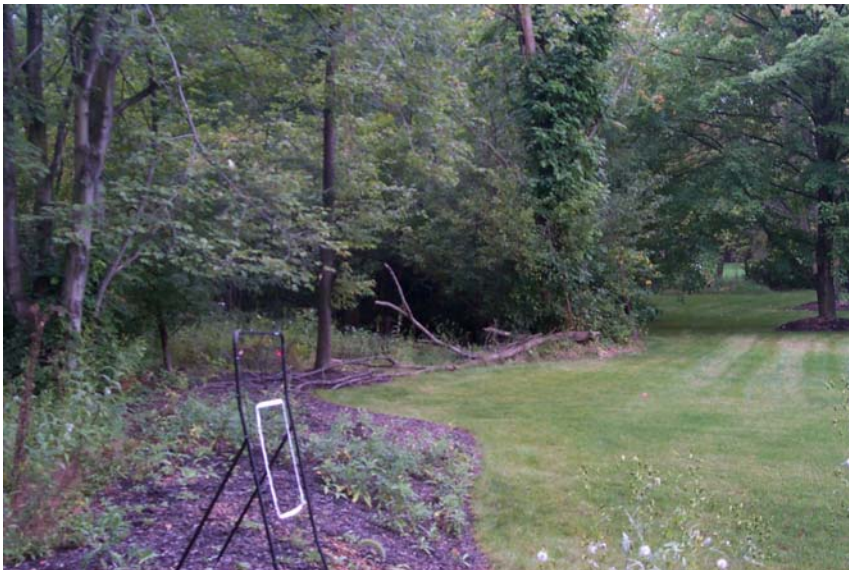
Photo 11: S along CE to left, SL 22 to right.

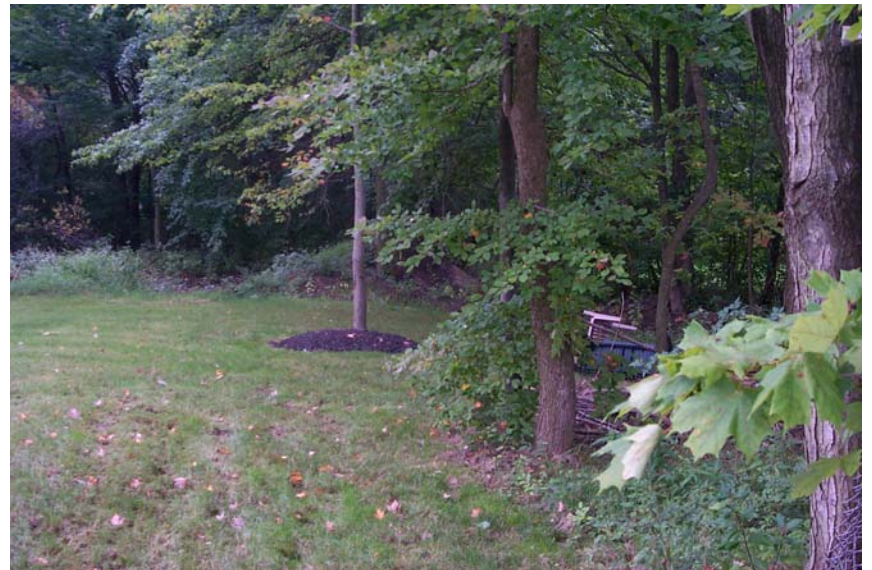
Photo 12: N along CE to right with debris, SL 22 to left.

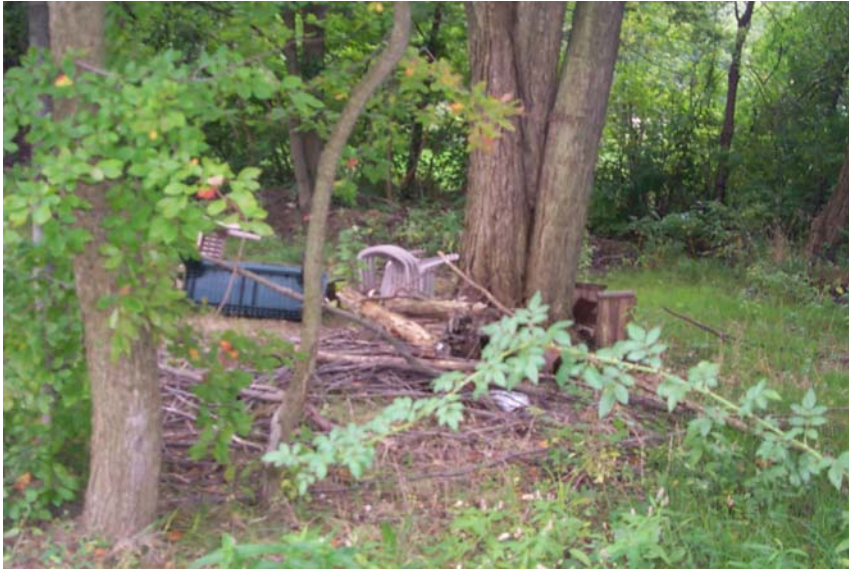
Photo 13: S along CE to left with debris, SL 22 to right.

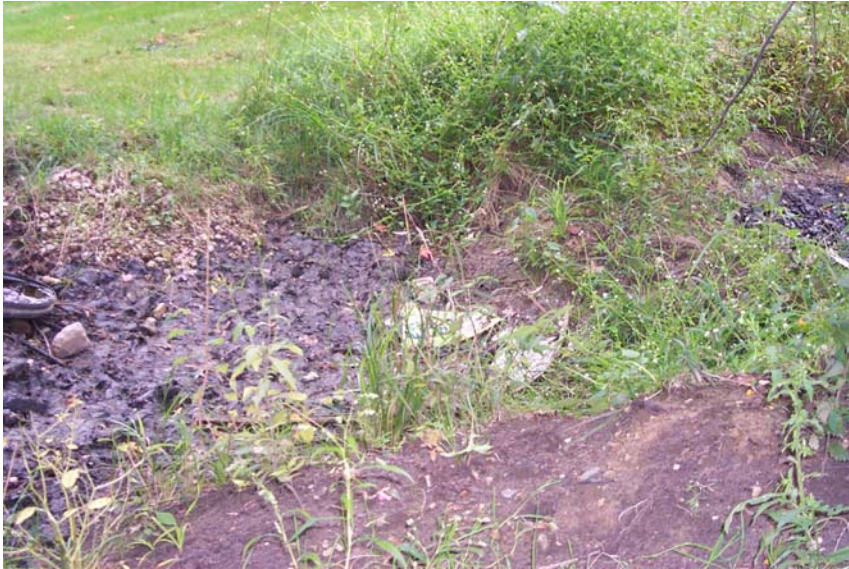
Photo 17: Drainage basin in CE from SL 22.

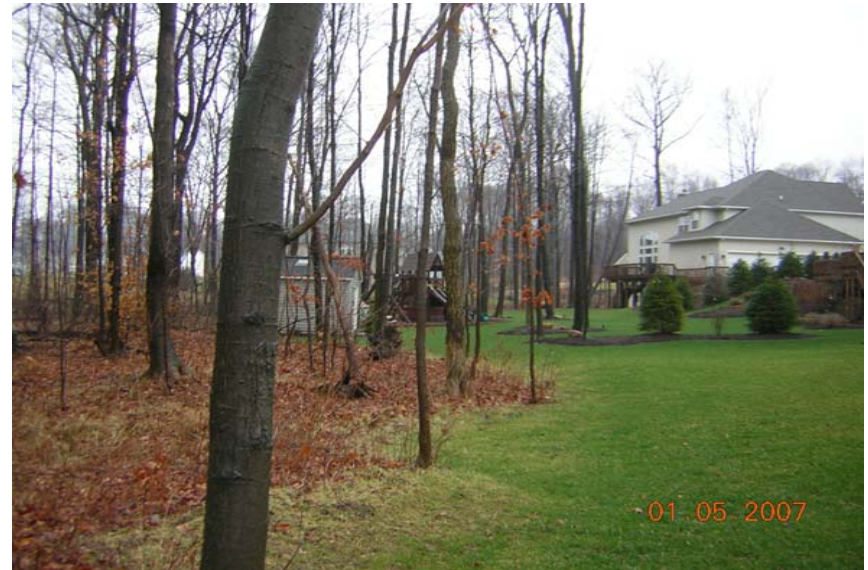
Photo 42: View NE along CE on SL 39.

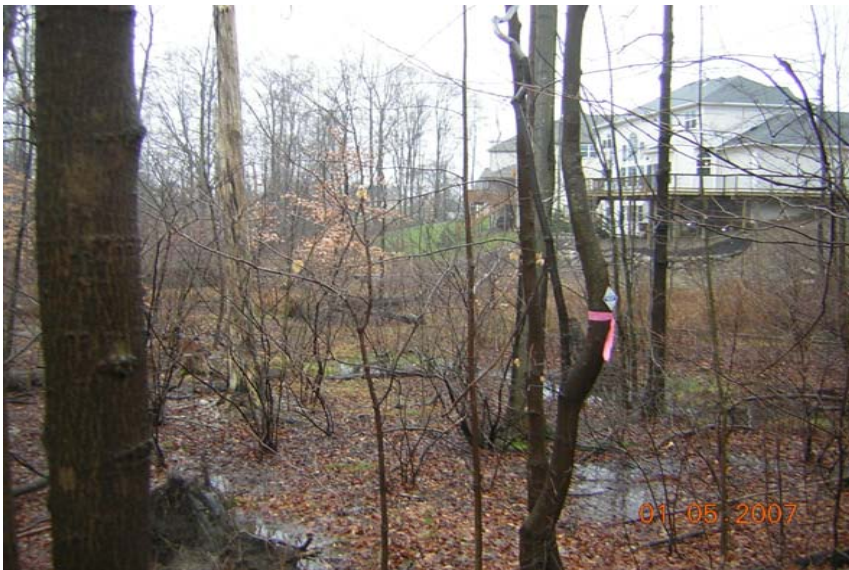
Photo 67: View S into and along CE from SL 166 to SL 102.

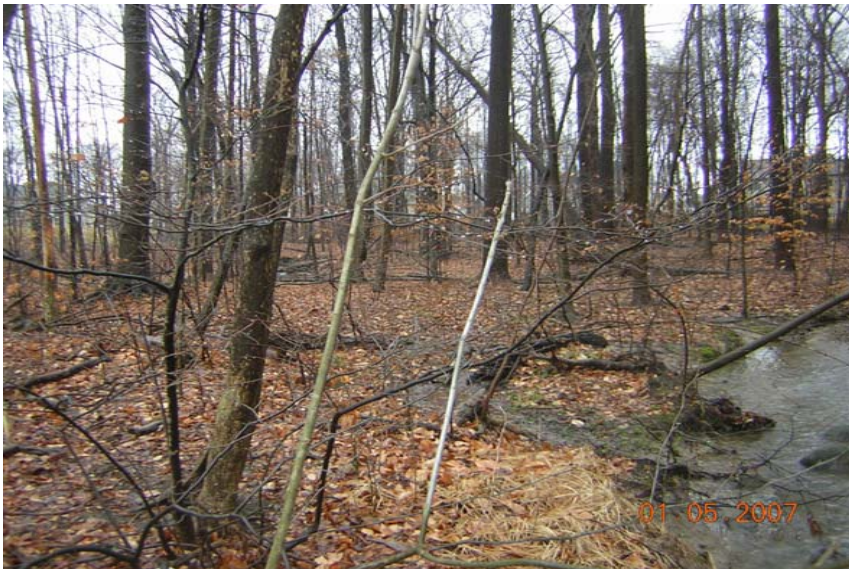
Photo 70: View W to stream in CE on SL 166.
