BASELINE DOCUMENTATION REPORT

**FOR
LAKE FOREST ESTATES
MACEDONIA, OHIO**

SUMMIT COUNTY, OHIO

**September 15, 2006
January 5, 2007**

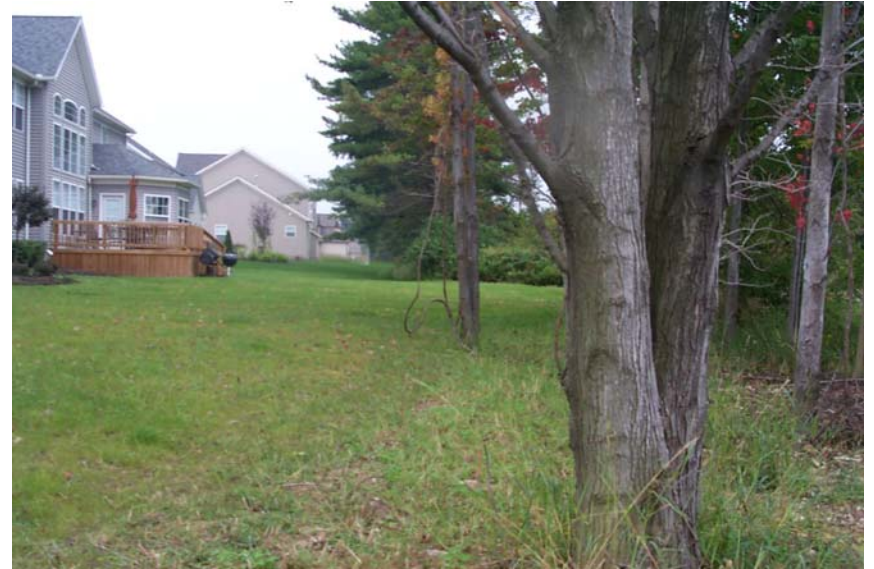
Photo 2: View SE along CEB, CE to right, from SL 118.

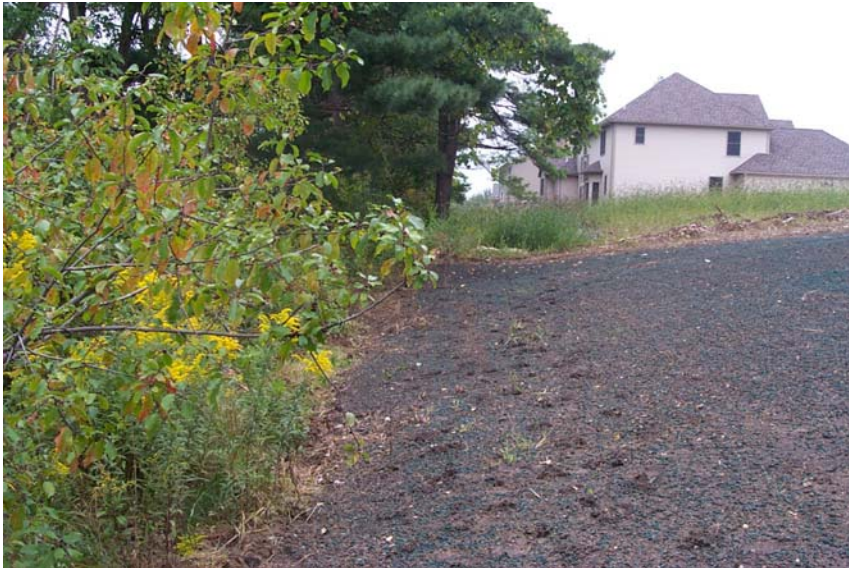
Photo 7: NW along CE to left, on SL 112.

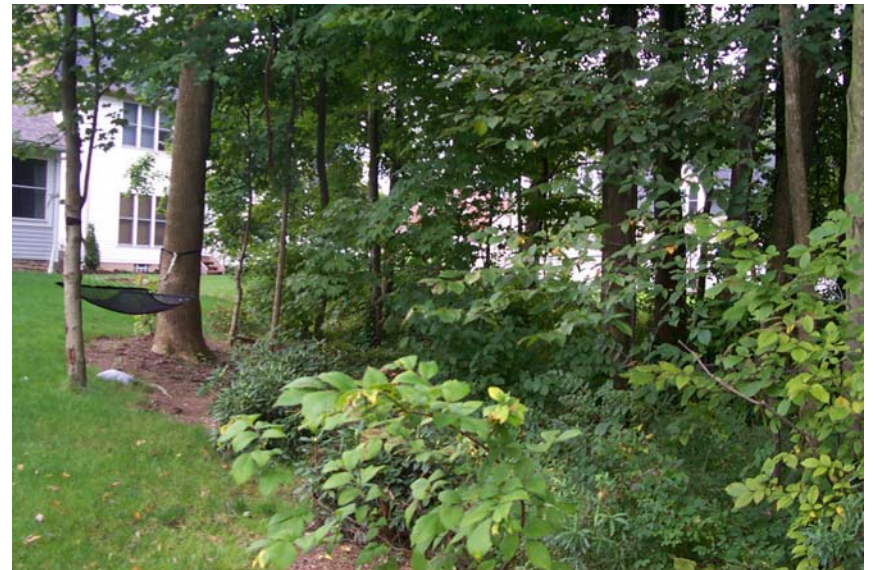
Photo 24: NE along CE to right to SL 23.

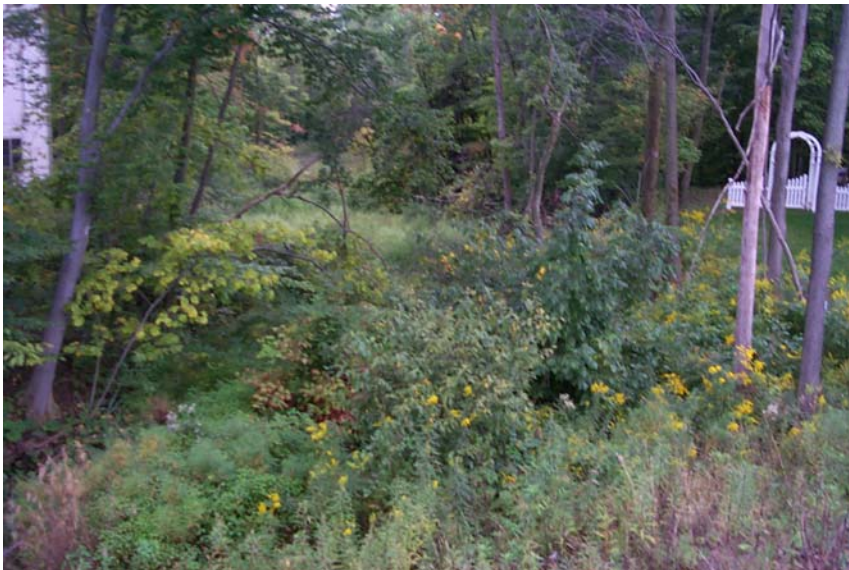
Photo 31: W into CE from River Run, SL 59 to left.

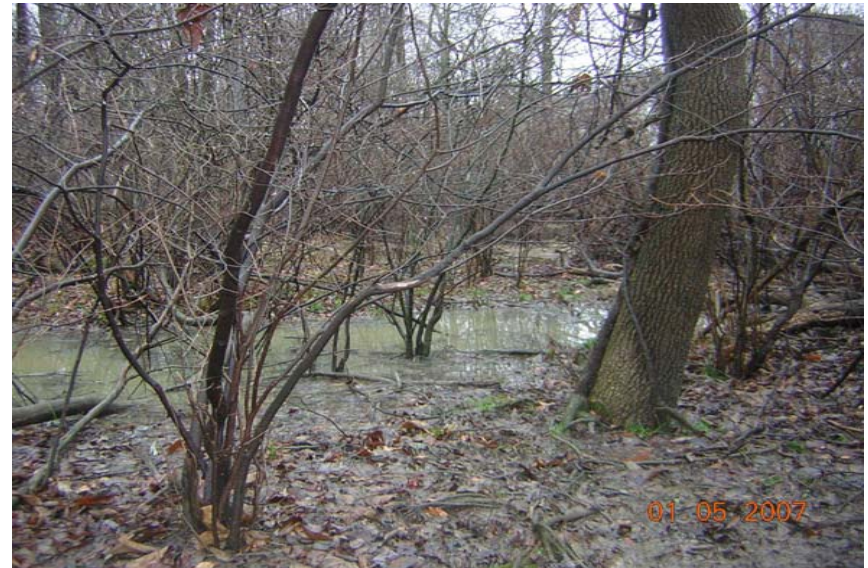
A closer look at the stream within the CE revealed fast flowing water, partially due to the recent rain we have had, with many meandering curves (see photos 53, 66, 69, 70). Several wetland areas with skunk cabbage were viewed along the SW portion of the CE located between River Run Drive and the cul-de-sac of Brook Circle (see photo 60). The wetland seen in photo 60 has a culvert on the south end which drains into the stream. Ponding is evident along the stream's floodplain (see photos 54 and 66).

Photo 54: View E within CE on SL 47. Floodplain of stream with skunk cabbage and thick shrubs.

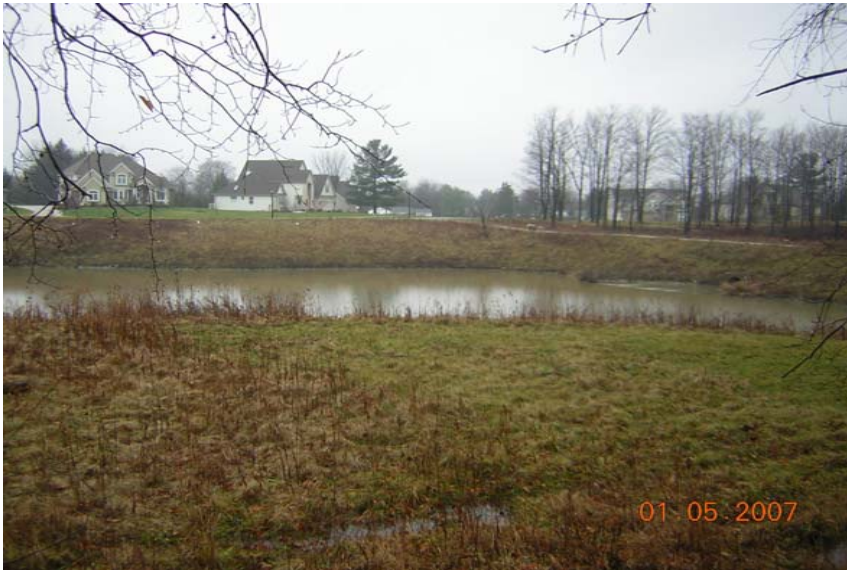
Photo 57: View SW into detention basin outside of CE with my back to SL 104.

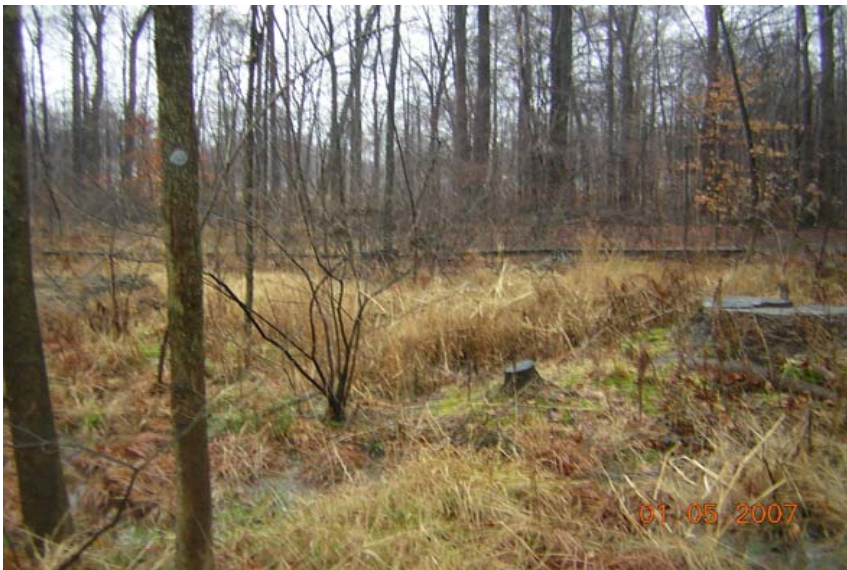
Photo 63: View SE into CE on SL 102.

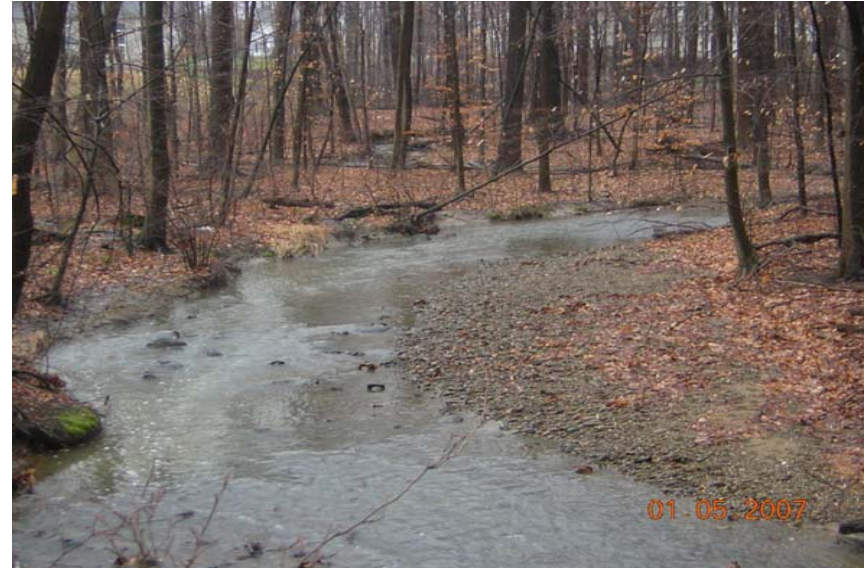
Photo 69: View S of stream in CE on SL 166.

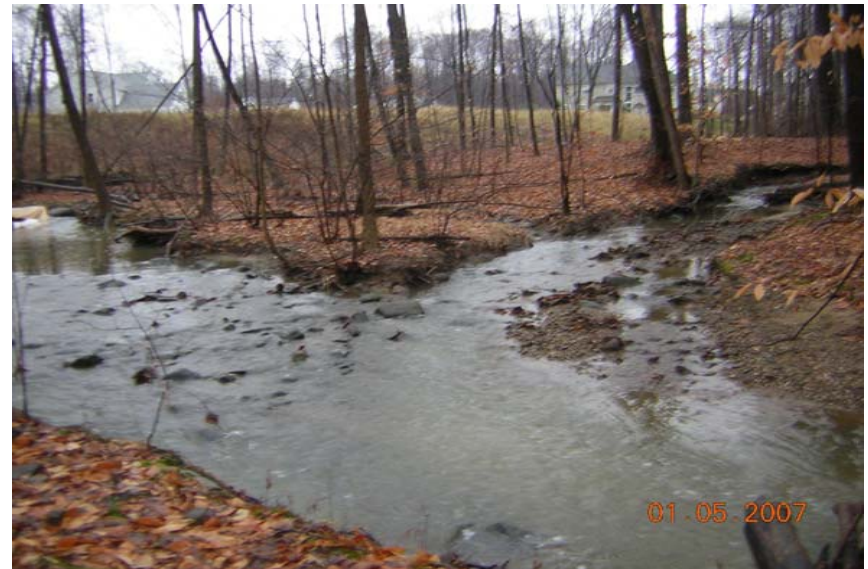
Photo 71: View N along CE to right and SL 165 to left.
